NISTIR 4504

# A Field Study of the Performance of EPDM Roofing at Air Force Facilities

Walter J. Rossiter, Jr.  
James F. Seiler, Jr.  
William P. Spencer  
Paul E. Stutzman

January 1991

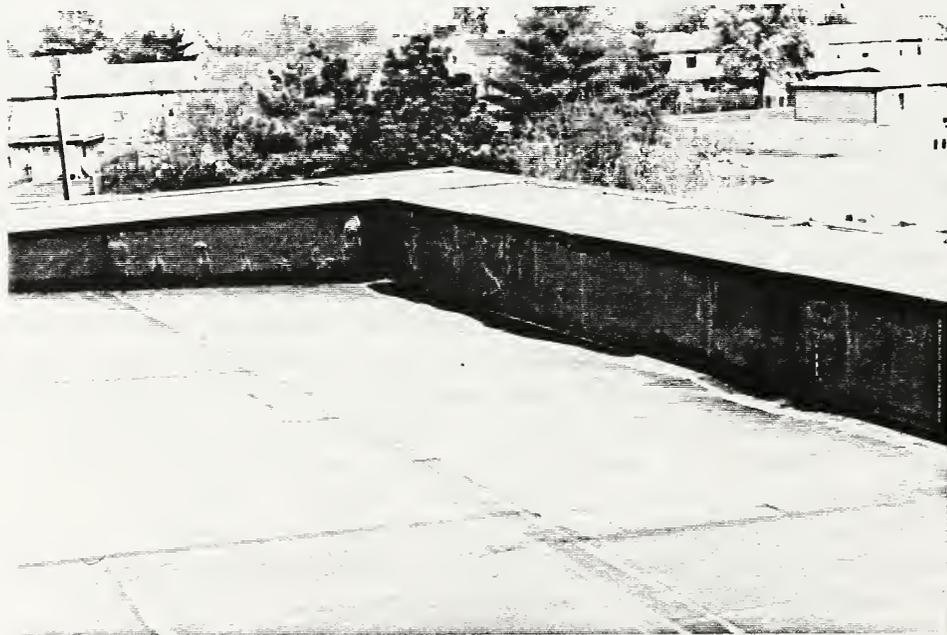
Inspections of the roofs where the seams were exposed showed that most of the seams appeared to be intact and tight. Figure 3 shows a seam typical of many seen during the inspections. In general, the seams showed few deficiencies such as edge delaminations or fishmouths. The interior portions of the seams could not, obviously, be inspected to assess their condition without cutting the membrane or delaminating the seams. In conducting the inspections, the edges of many seams were probed with the tip of a blunt blade to determine whether the seam edge offered significant resistance to delamination. This was generally the case, but the use of such a rough technique to probe seams emphasized the need for reliable nondestructive methods.

Figure 3. A seam typical of many that were observed during the study

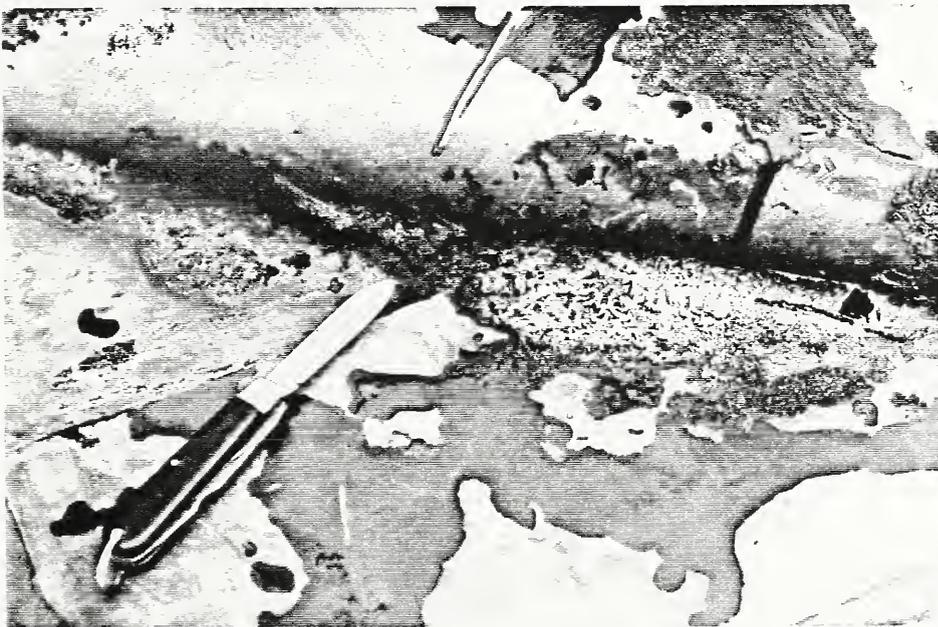
Seam problems at one building were attributed to material deterioration; at two other buildings, they were ascribed to unacceptable workmanship during installation. In the former case, seams having an adhesive reported by facility personnel to be neoprene-based<sup>3</sup> had deteriorated, as shown in Figure 4. This roof was about 4 years old when the problem first arose. In this case, the adhesive was seen to have delaminated from the rubber, lost cohesive strength, and taken on a mushy consistency. This observation was consistent with field experiences in that seams with neoprene-based adhesives have, in some cases, deteriorated after some years in service [13,14]. Technical reports describing the problem, its extent, and factors contributing to its occurrence have not been published in the roofing literature. One short review [14] on the effect of moisture on roof system performance stated that "neoprene cements that joined individual sheets and were used as flashing cements were sensitive to elevated temperature and water."

A notable aspect of the deterioration of the seams having the neoprene-based adhesive was that it did not occur randomly over the entire roof. On the contrary, it was confined to one section, which comprised not more than 25 percent of the roof area. Moreover, patches placed over the original deteriorated seams also experienced delamination. The adhesive for the patches was also reported to be neoprene-based. To the extent that it could be determined without delaminating seams that appeared to be functioning well, the seam

Figure 4. Delaminated seam having neoprene-based adhesive

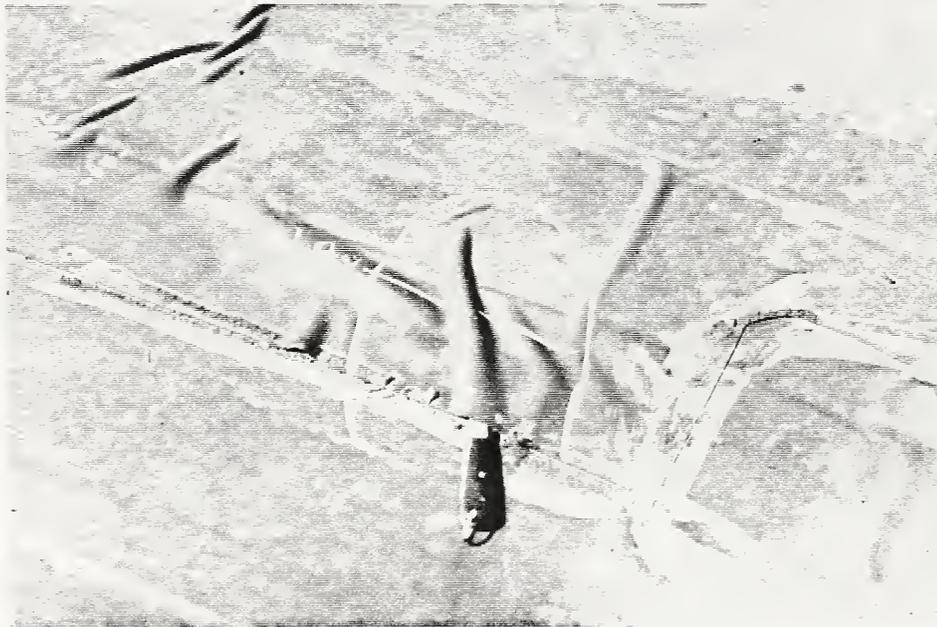
In the second case of seam problems, two roofs at the same installation (and applied by a single contractor under the same contract) that had experienced major problems; the seams contained numerous fishmouths and ripples. This was considered to be due to unsatisfactory workmanship, although the possibility that the EPDM sheets were not adequately flat or rectangular (which could have lead to ripples in their installation) could not be ruled out. Many of the ripples, but not all, bridged the entire width of the seam, and were obvious sources of leaks (Figure 5). In addition, the adhesive in the seams was extremely thick (about 50 mil or 1.3 mm). During application, thick adhesive layers retain the solvent longer than thin layers and require longer open times before the sheet surfaces bearing the adhesive can be mated together [15]. The longer retention of solvent may lead to excessive swelling of the rubber at the edges of the sheets where seams are to be made. The swelling is manifested as ripples which could, in turn, be incorporated in the seams. An example of this observation is given in Figure 6, where it is evident that the rippling is essentially limited to the seam section of the membrane. Such ripples are sources of peel stress that may delaminate the seam bond and produce leaks [16].

Figure 5. Fishmouth bridging the seam

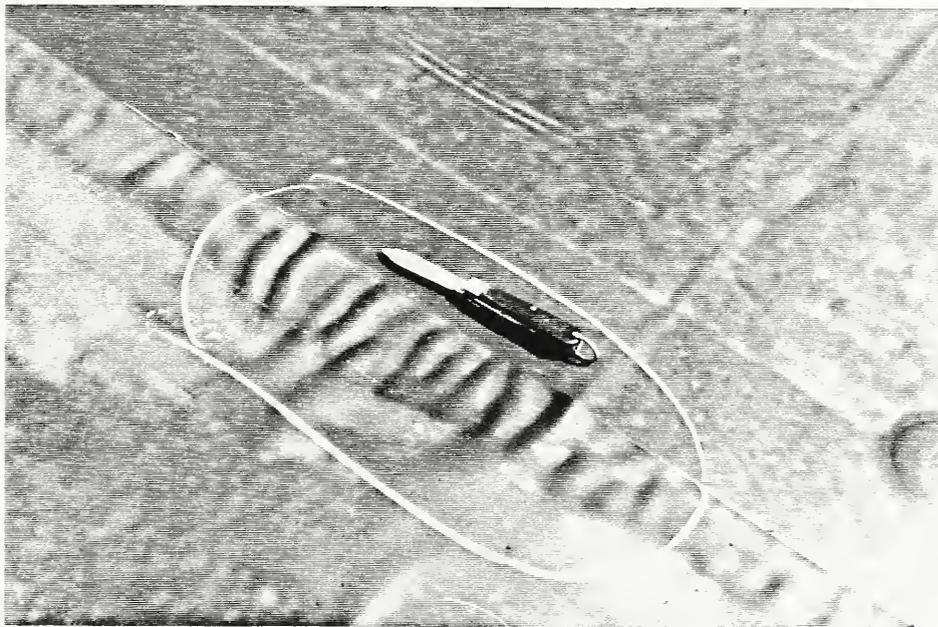
Figure 6. Ripples in the seam attributed to swelling of the rubber during adhesive application

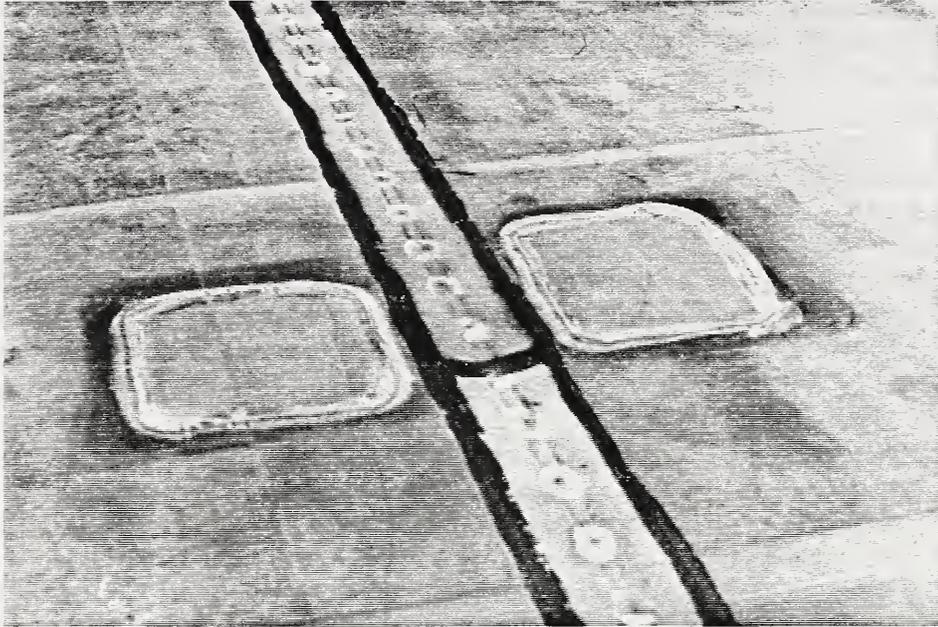
Figure 7. Patches along side of a cover strip over mechanical fasteners; the patches had performed well

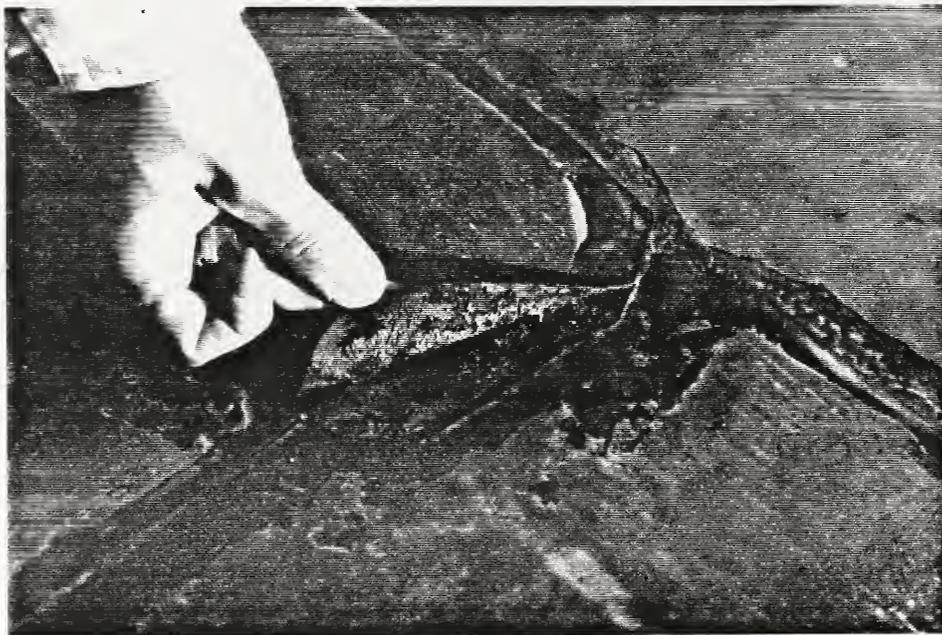
As was the case for seams, the conditions of the majority of the patches observed in the study appeared satisfactory, as probed with the tip of a blunt blade to determine whether they could be readily raised from the membrane surface. Generally, this could not be done. Figure 7 shows two patches adjacent to the covered fasteners in a mechanically attached system. They had reportedly performed well for the two years they were in service. The appearance of these patches was typical of most observed, and few patches with deficiencies (i.e., sections or edges not bonded to the membrane surface) were seen. The most significant case was the previously-mentioned roof (Section 3.4.2) where the adhesive-bonded patches over seams having neoprene-based adhesive, had also deteriorated. Such deterioration of patch adhesive was also found at two other installations (Figure 8), but the phenomenon was limited to a single patch per roof.

Figure 8. A patch with deteriorated adhesive; such observations were uncommon

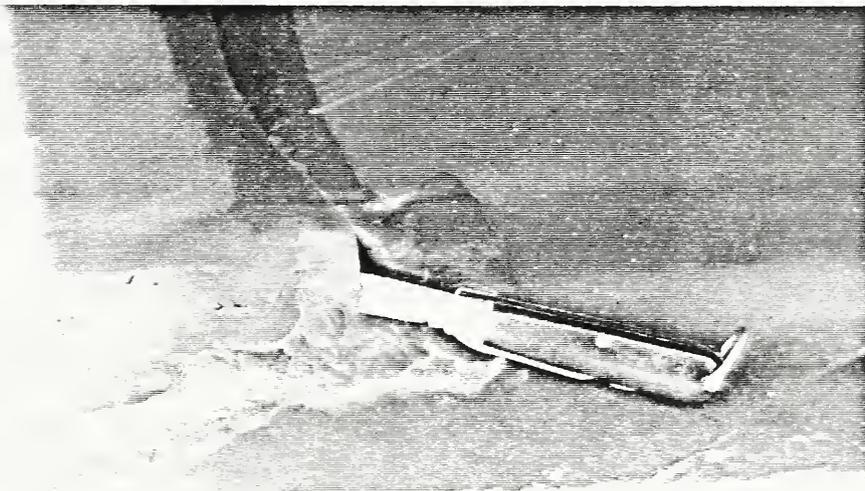
3.4.4 Flashings. The rubber base flashings observed at penetrations and perimeters of the buildings were, with one exception, in generally good condition. A common deficiency, found on a number of roofs, was a limited section of flashing which was not sealed, but contained an opening or disbond, as illustrated in Figure 9. Reasons for these defects were not always apparent but, in some cases, it was considered that the flashings had not been properly sealed when constructed. Although the observations were limited, the findings of open sections of flashing illustrate the need for good periodic maintenance inspections, and the ability for inspectors to have timely repairs made.

Figure 9. Small opening in a flashing; this was typical of many flashing defects observed

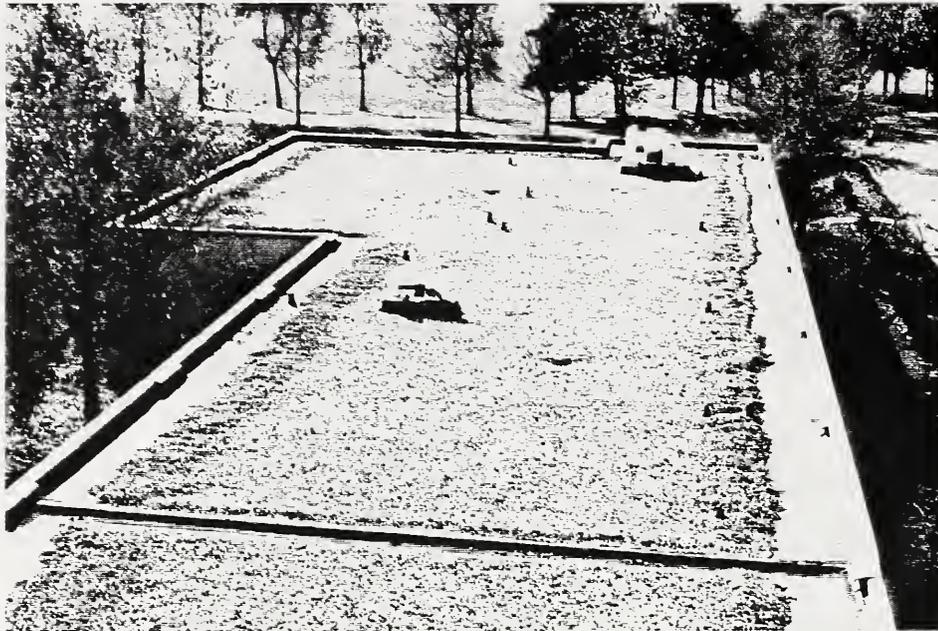
Figure 10. Roof with ballast swept back from the perimeter to allow ready inspection of the base flashing

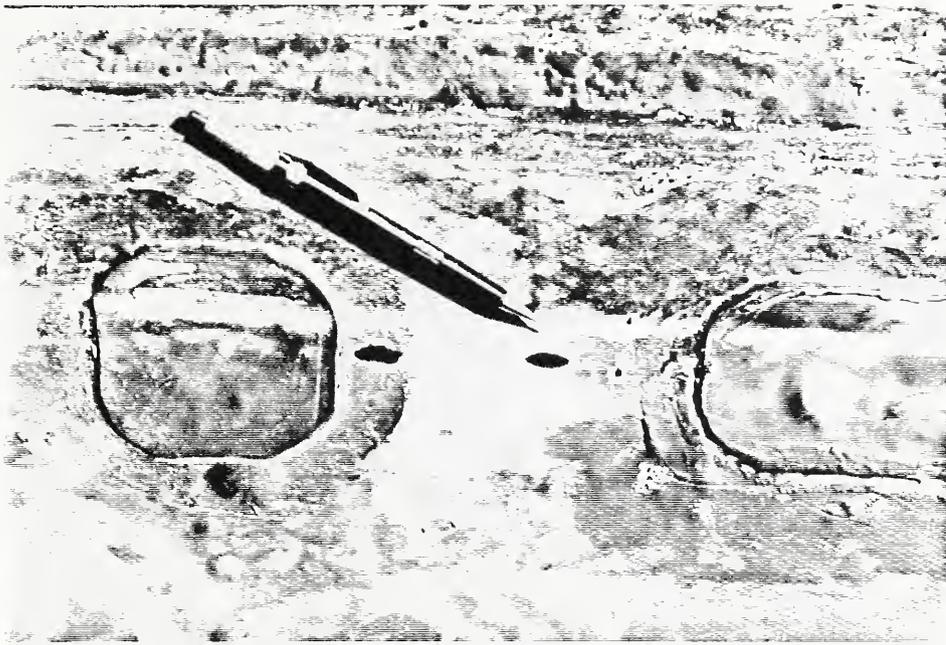
At one installation, the perimeter base flashings of a ballasted membrane system were uncured neoprene-based rubber. This flashing material had cracked extensively and randomly over the entire perimeter area during the 7 years the roof had been in place. The problem was so extensive that the ballast had been swept back from the building perimeter to have all flashing areas visible for frequent inspection (Figure 10). Many of the cracks had been patched, although some were open to water penetration into the building. The cracks were limited in length, normally a few inches (centimeters) (Figure 11). They occurred at the edge of a wooden cant strip, where the flashing was stretched tight. Apparently, this produced excessive stress in the rubber at that location, which resulted in the cracks.

Figure 11. Cracks and patches in deteriorated base flashing

Maintenance personnel at this installation normally repaired the cracks in-house by covering them with patches. Most of the patches appeared to be in satisfactory condition, while some contained small cracks similar to those in the original flashing. It was indicated to NIST staff that plans were under development to replace the perimeter flashing, because of the extensive time spent in monitoring and repairing the flashing.

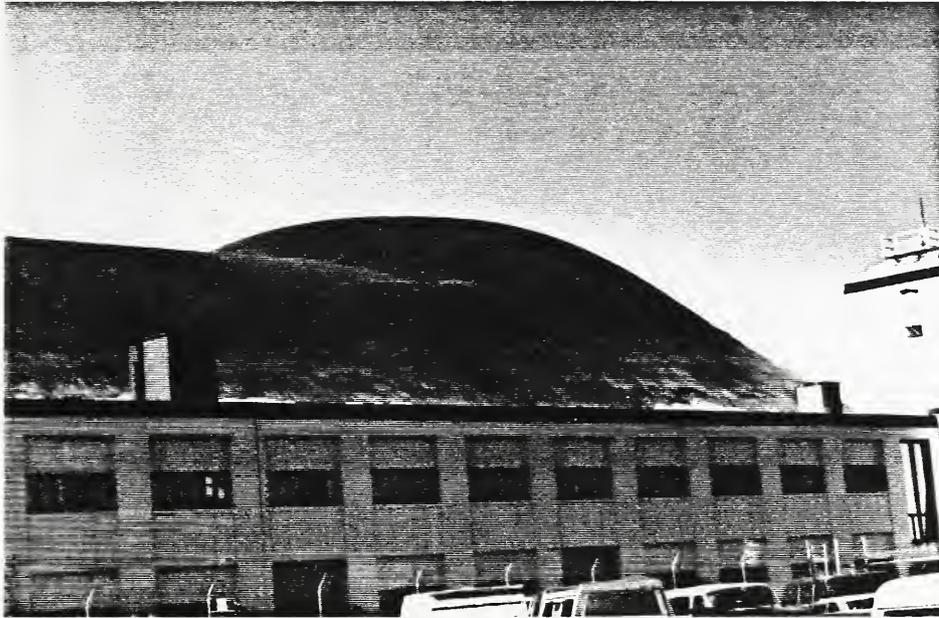
In the first, an adhered membrane was placed directly on an existing BUR system on a barrel roof of a hangar. The existing BUR membrane was apparently granule-surfaced. During high winds (speed not indicated), a section of the membrane lost adhesion to the substrate and billowed extensively, but did not blow away. Figure 13 is a photo of the billowing taken during the wind storm, and made available to NIST during the field visit. A repair was made which involved slicing open sections of the loose membrane, re-adhering it to the substrate, and seaming the areas of the slices. When the roof was inspected, the repair had been in place 4 months during which high winds had not occurred. Field personnel were concerned that the billowing problem (or worse) might recur, since they had no means to assess the adequacy of the re-bonding of the membrane to the substrate. They asked whether a test procedure was available that was applicable to both the repaired section and the undamaged section of the EPDM membrane. Standard methods to assess the adhesion of the EPDM rubber to the surface of an existing membrane have not been developed. It is possible that the ASTM Method E 907, "Field Testing Uplift Resistance of Roofing Systems Employing Steel Deck Rigid Insulation and Bituminous Built-Up Roofing," may be applicable, because it provides a measure of the adhesion between components [18]. Data supporting its applicability to the EPDM adhesion question would need to be developed.

Figure 13. Billowing of the EPDM membrane on a hangar roof during a wind storm

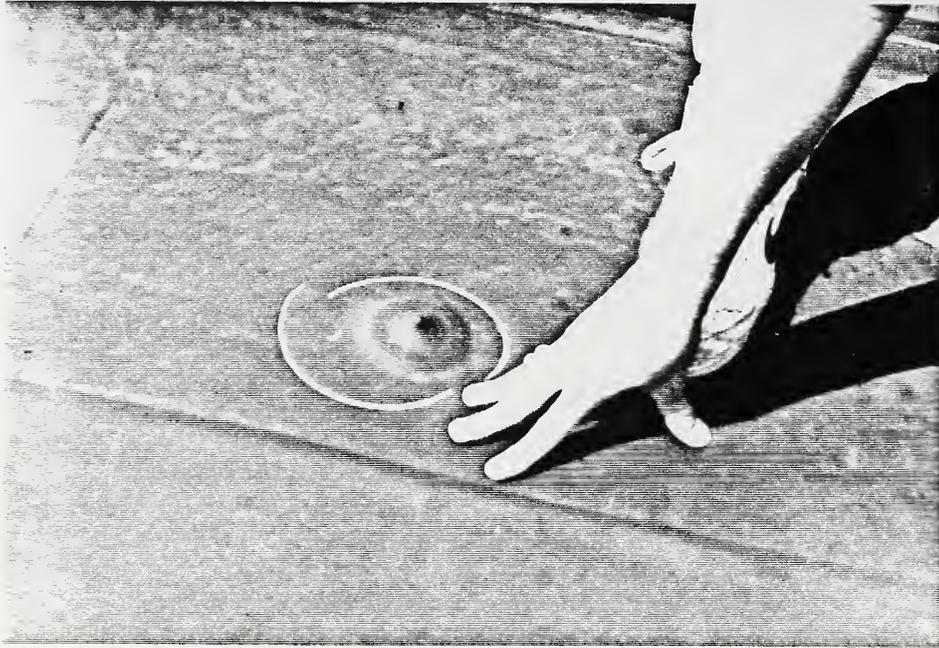
For many adhered systems, a number of observations were seen where fasteners used on insulation boards had apparently backed out and the fastener heads were pushing against the membrane. For the majority of the observations, puncturing of the membrane due to fastener backout had not occurred (Figure 14); however, in a few instances, it had (Figure 15). Backout of fasteners is a maintenance item for field personnel to consider during routine inspections.

Figure 14. Example of an isolated fastener that backed out from the deck; the membrane was not punctured

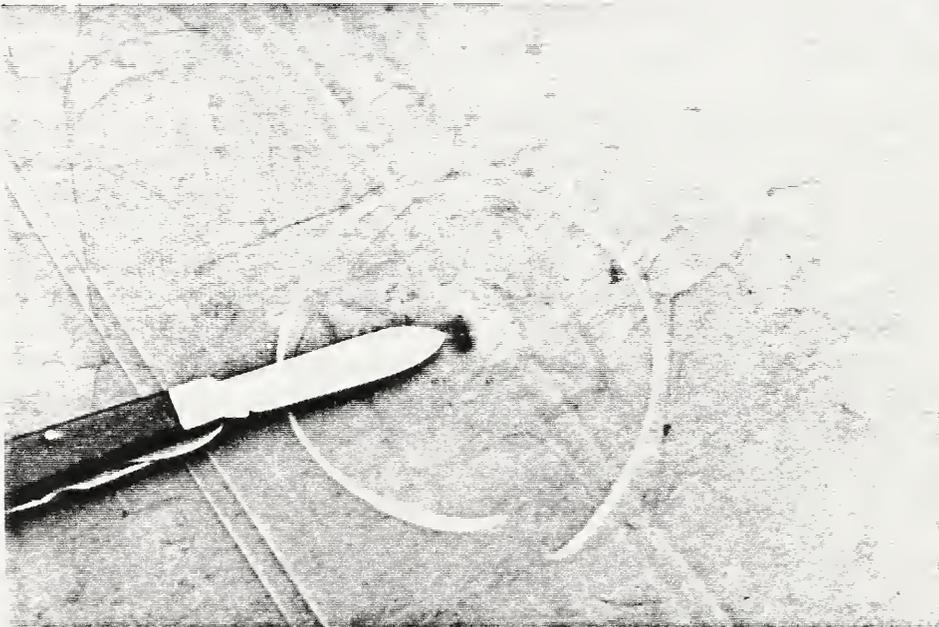
Figure 15. Example of an isolated fastener that backed out from the deck; the membrane was punctured

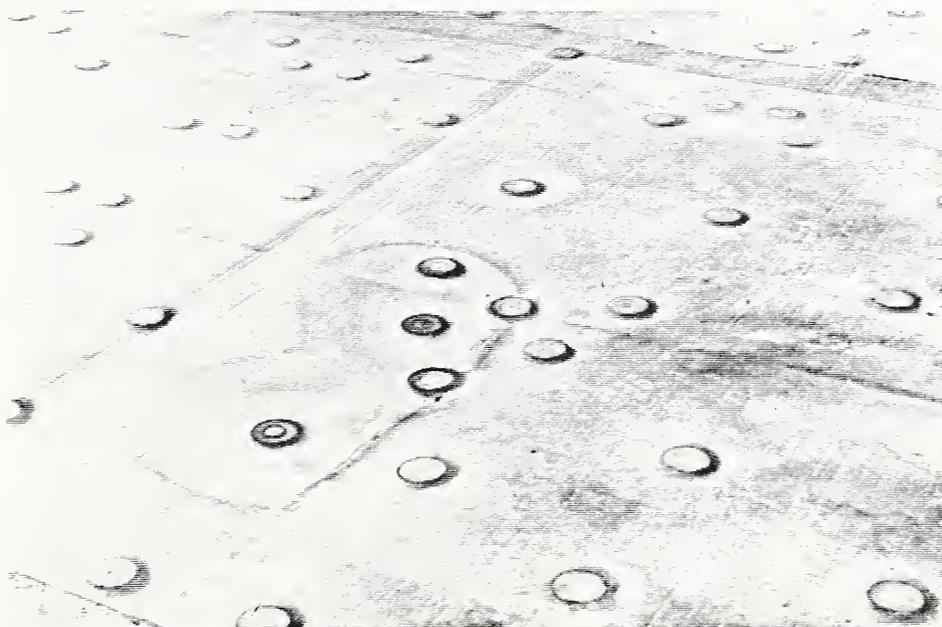
At one installation, the stress plates of mechanically fastened insulation in an adhered membrane system were set high on the top of the insulation boards (Figure 16). As a consequence, the membrane was stretched at the areas over the tops of the stress plates. In a limited, confined area (estimated to be about 10 %) of the roof, the membrane had split at the edges of some of the stress plates (Figure 17). The stretching of the membrane where the splits had occurred did not appear to be more extensive than that observed in areas without splits. Because the splitting was not random across the roof, a question was raised whether the membrane material in the areas of the splits was less resistant to stress cracking than that installed on the majority of the roof surface area. If such were the case, the risk of additional splitting occurring at other locations of the roof might be low. Nevertheless, periodic maintenance inspections should closely examine the membrane at each fastener stress plate to assure watertightness.

Figure 16. Stress plates set high on the insulation boards

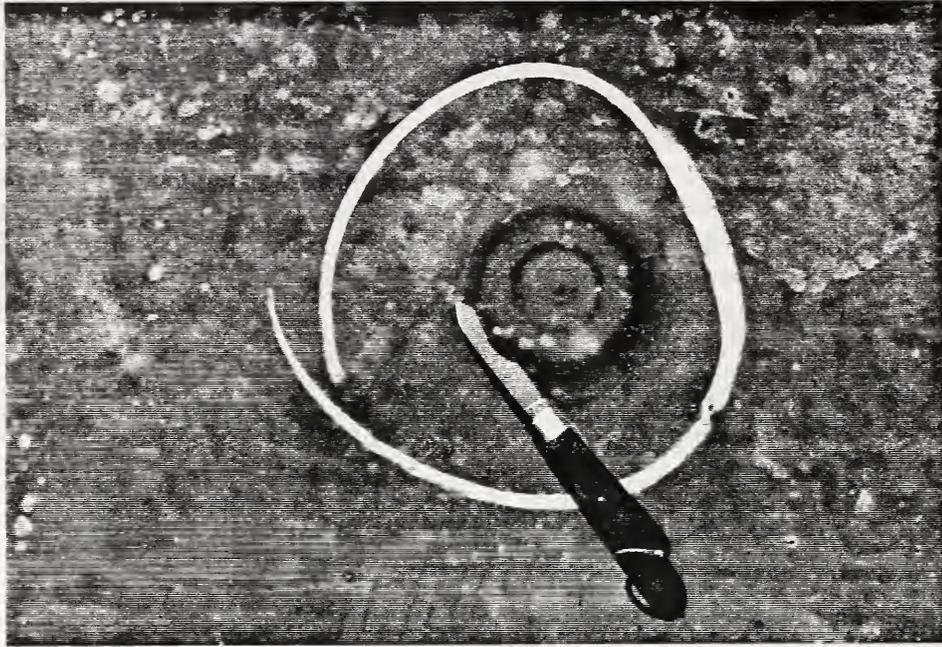
Figure 17. Split in the rubber membrane at the edge of a raised fastener stress plate

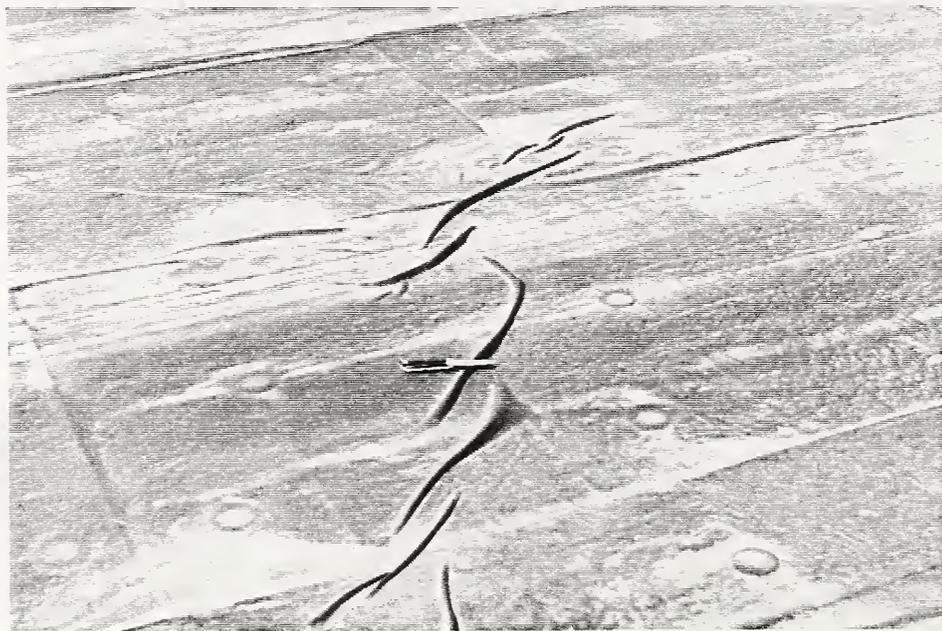
As a final point regarding adhered systems, the occurrence of wrinkles and ripples incorporated in the membrane during application is mentioned. For the majority of the roofs, wrinkles and ripples were essentially non-existent (e.g., Figures 3 & 10). However, for two roofs, they were found to be rather numerous (Figure 18). In these cases, no evidence of cracking of the rubber at these locations was found. However, if wrinkles and ripples occur in the area of seams (as discussed in Section 3.4.2), they produce fishmouths, and even if sealed tight, they subject the seams to peel stress [16].

Figure 18. Area of an adhered system with a number of wrinkles in the membrane

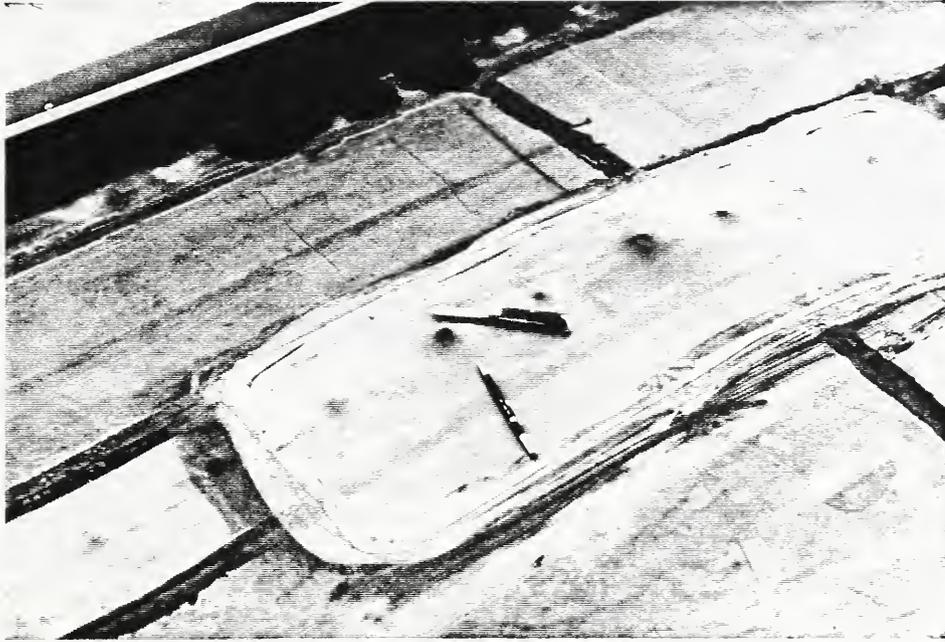
Figure 21. Mechanically-fastened system showing little fastener backout

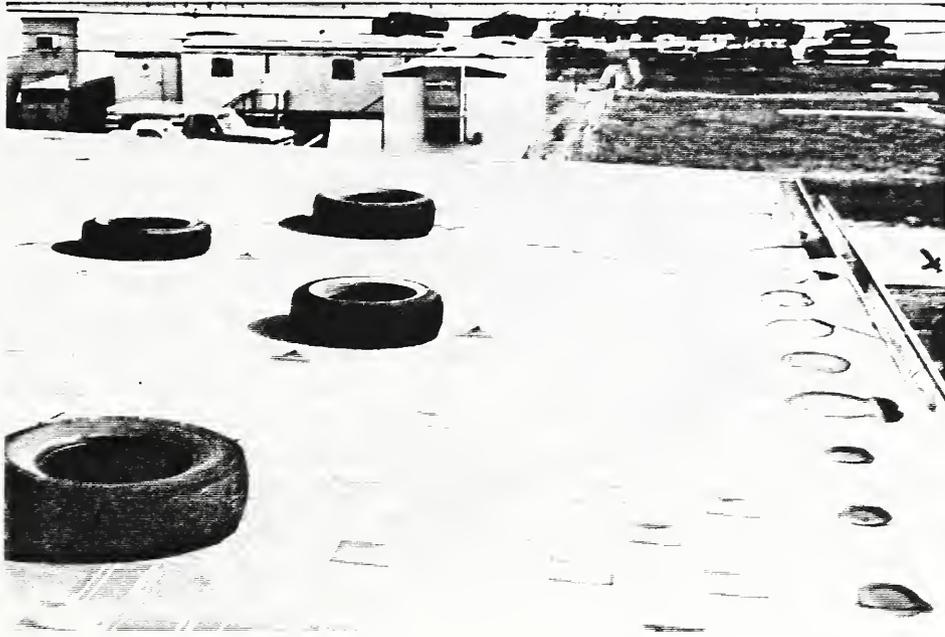
Figure 23. Used tires ballasting a section of a mechanically fastened system to provide temporary securement

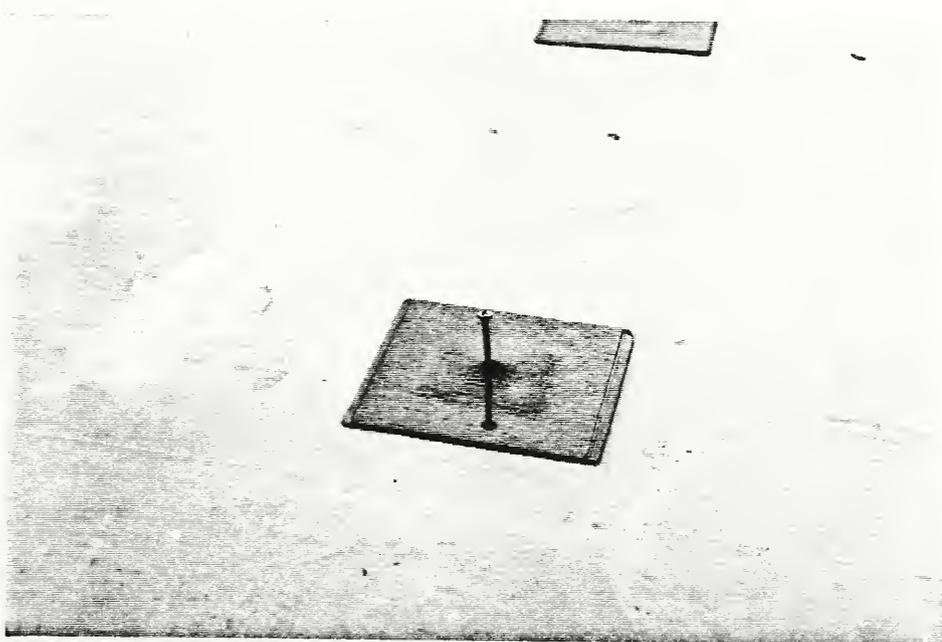
The mechanically fastened system in question used spot attachment in which each fastener was individually covered with a patch to seal the locations where the fasteners penetrated the membrane (Figure 23). In some locations on this roof, the fastener backout had been extensive enough to puncture the cover patches (Figure 24). The fastener backout had only occurred on the windward side of the building, about 10 to 20 ft (3 to 6 m) from the edge. Note in Figure 23 the position of the temporary ballast away from the edge of the building. It was at this location that the fastener installation pattern became less dense, switching from 2 to 4 ft (0.6 to 1.2 m) on centers. On the day of the inspection, a slight breeze occasionally blew. Whenever it occurred, sections of rubber membrane between the 4 ft (1.2 m) fastener spacing and in the area of the tire ballast stretched slightly and fluttered in the wind. Wind flutter resulting in fastener backout is known to occur in practice [23]. In the present case, the fluttering effect was not noticeable where the fastener pattern was 2 ft (0.6 m) on centers at the building edge where the fasteners had not backed out.

Figure 24. A backed-out fastener which punctured the cover patch sealing the penetration

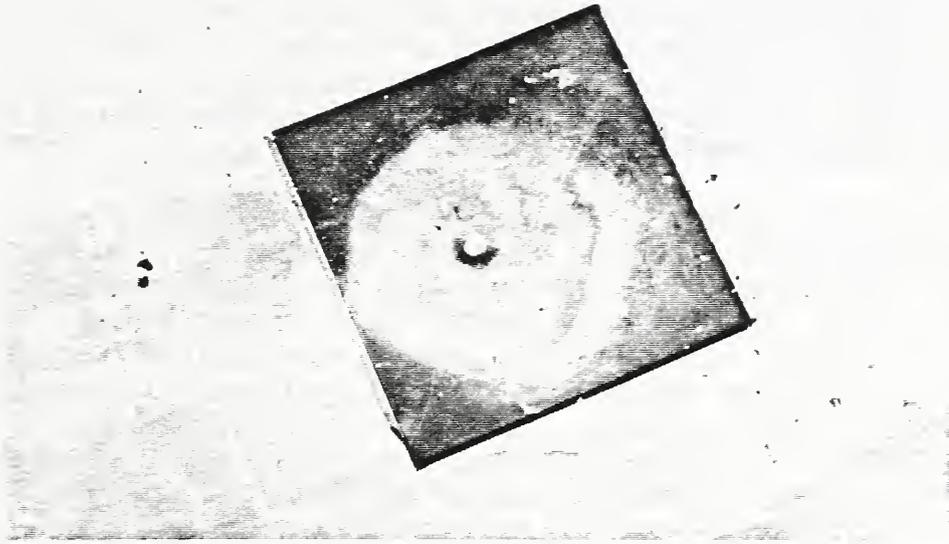
The second mechanically-fastened roof where field personnel indicated that they were not satisfied with the securement system was a spot-attached system of the type previously shown in Figure 23. In this case, the question of concern was not fastener backout, but proper sealing of the spots where the fasteners penetrated the membrane. For this system, as previously indicated, each fastener was individually covered with a patch to seal the penetrations. The concern was that many of the patches were not adequately centered over the fastener or adhered to the membrane. Figure 25 shows an off-center patch which provides little bond area on one side of the fastener plate. Figure 26 illustrates patches that were only partially adhered to the membrane. It was not known whether this latter condition resulted from unsatisfactory installation, or some disbonding of the patches after their installation. Field personnel stated that no leaks were reported in the field of the roof, indicating that the patches on the fasteners were functional in spite of the observed deficiencies. Repairs to off-center or partially disbonded patches are needed and close inspection of the system is required to assure that these patches continue to be watertight.

Figure 25. Off-centered patch over a fastener penetration; little bond area is provided on one side of the patch

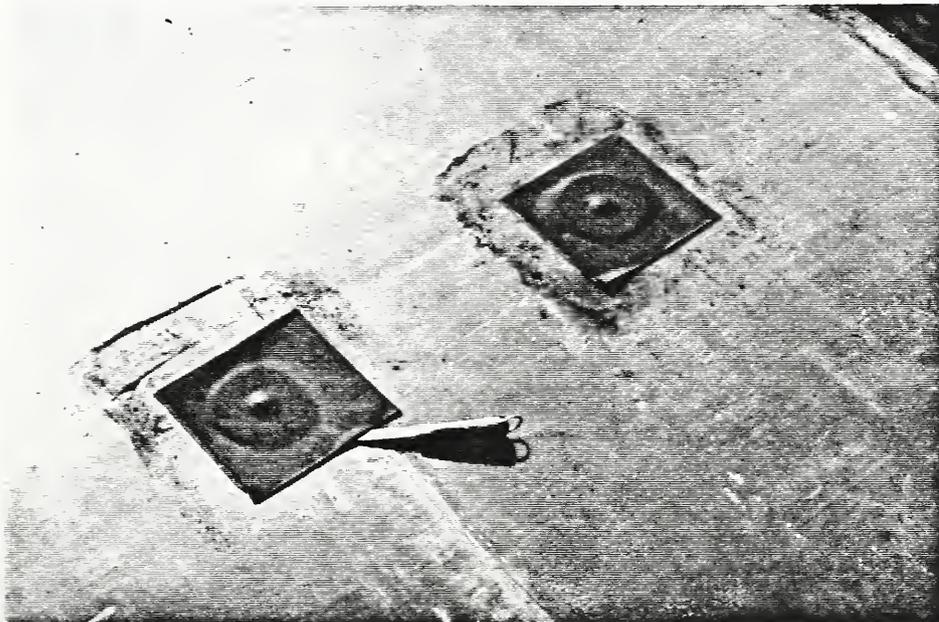
Figure 26. Lack of total adhesion of a patch over a fastener penetration

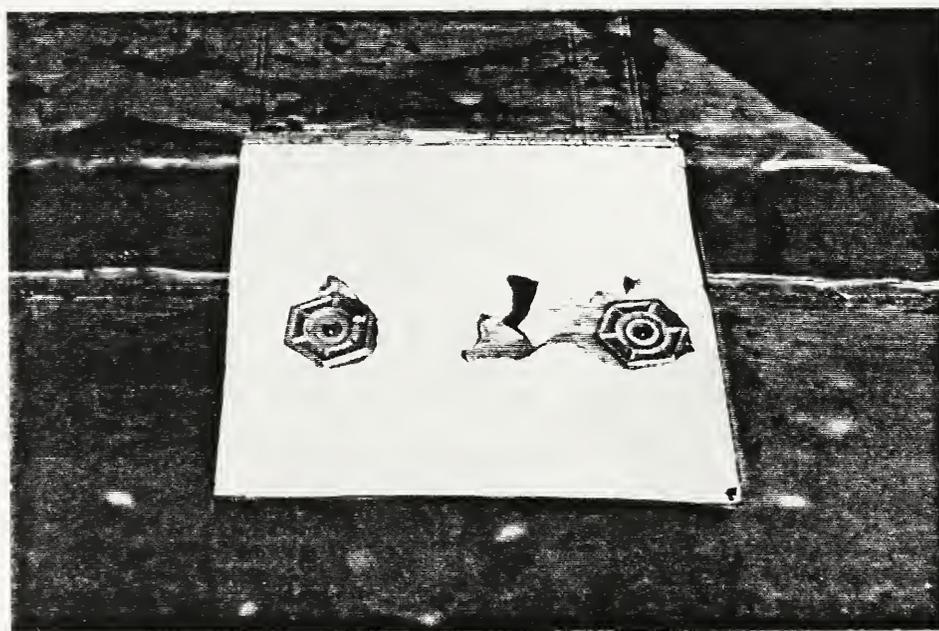
Some observations, though limited, regarding the corrosion question were made during the study. Fasteners securing insulation in adhered systems were uncovered on three buildings (one observation in each case), when seam samples were cut from the membrane. These fasteners were not removed from the roofs, whose ages were 18, 24, and 60 months. In the three cases, no visual evidence of corrosion was found on the exposed fastener heads or stress plates (Figure 27). Also no evidence of excessive moisture (e.g., liquid water) was found in the insulation. Although extremely limited, the observations concerning fastener corrosion were consistent with the general findings of the NIST review of the fastener-corrosion question [24]. In the review, it was indicated that fastener corrosion has been generally found when a roof is wet, and not found when it is dry.

Figure 27. Fastener heads and stress plates uncovered during seam sampling; no corrosion was evidenced

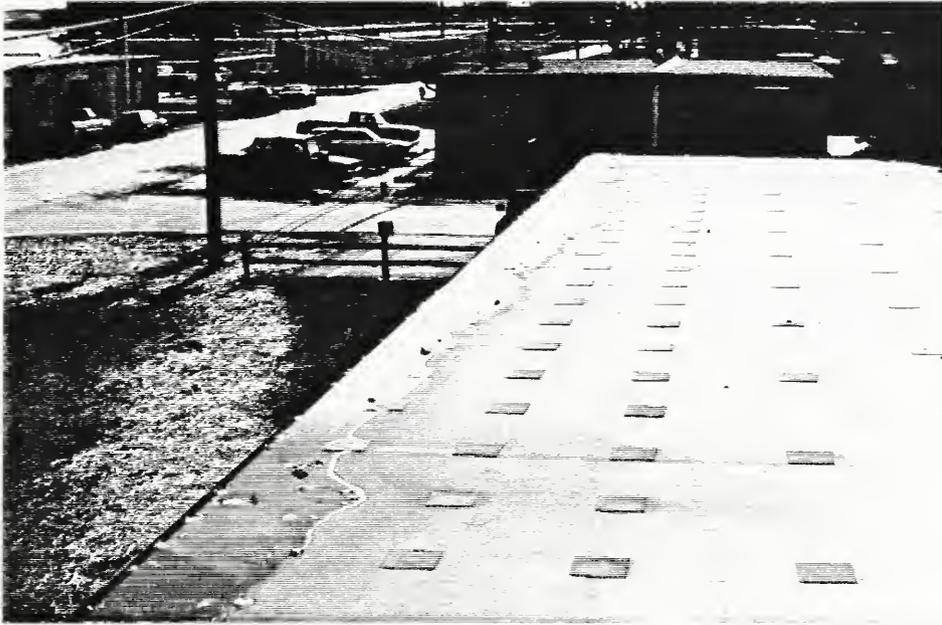
In spite of the generally good drainage, as might be expected, adequate slope did not exist over all sections of the roofs. In many cases, some areas showed indications of minor ponding, as evidenced by standing water or dirt deposited on the roof surface at locations where the water had collected and evaporated. Often, the minor ponding occurred along the edge of the roof, indicating that the slope in those locations was not sufficient. Figure 29 is an example of ponding along the roof edge. Perimeter details should consider sufficient slope to allow water to flow better over the roof edges.

Figure 29. Roof with generally adequate slope, except that ponding occurred along an edge

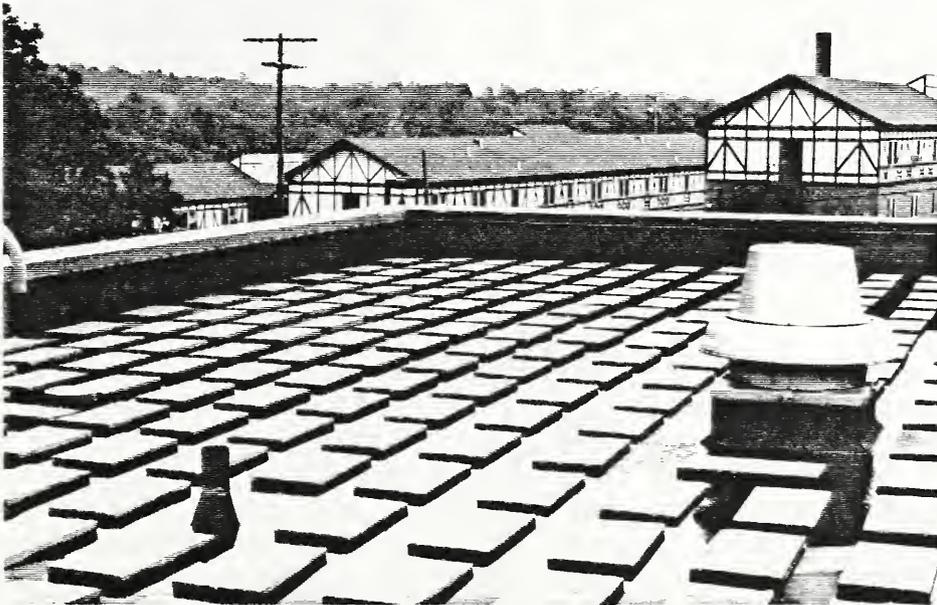
Major ponding of water was observed for one building. This roof contained a paver-ballasted membrane which was essentially totally covered with water (Figure 30). The strainer of one drain was found to be clogged with debris, but its removal did not drain the roof. The roof needs to have all the drains closely examined to determine whether they are open or not. Undoubtedly, a leak in this roof would result in considerable water entering the building. With all the water present, it was not possible to judge whether sufficient slope was incorporated in the system. Note in Figure 30, however, that the height of the two parapet walls does not apparently change across the edges of the building. It was not known whether the ballast caused undue deflection of the roof, and thus contributed to the ponding. However, as is seen in Figure 30, the pavers were not continuous across the field of the roof. A question raised was whether the partial covering of the membrane surface with pavers was done because the roof could not sustain total coverage. This roof was 8 years old and had reportedly performed well over this time. Field personnel indicated that leaks, attributed to flashing problems where two sections of the building tied together, had occurred but were repaired. Since then, the roofing was reported to be leak-free.

Figure 30. Extreme ponding of water on a ballasted system

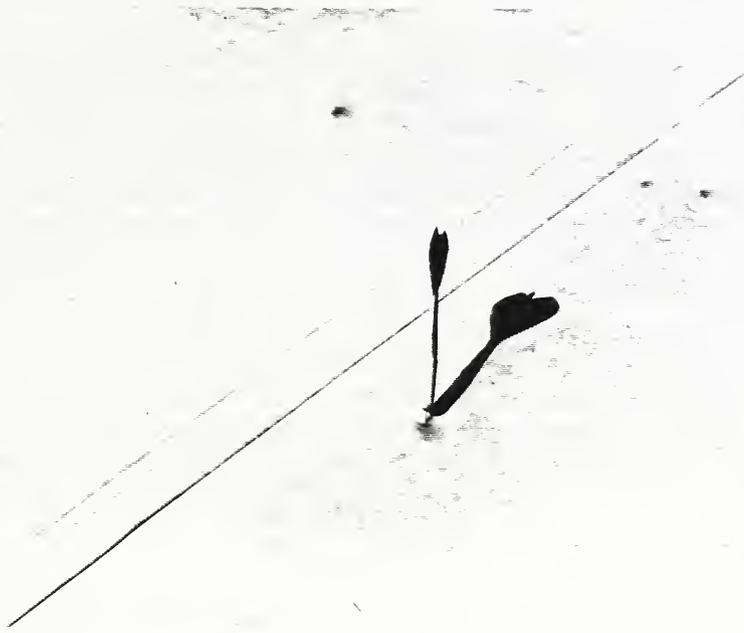
Figure 31. Example of abuse to an EPDM membrane; a dart was found stuck in its surface

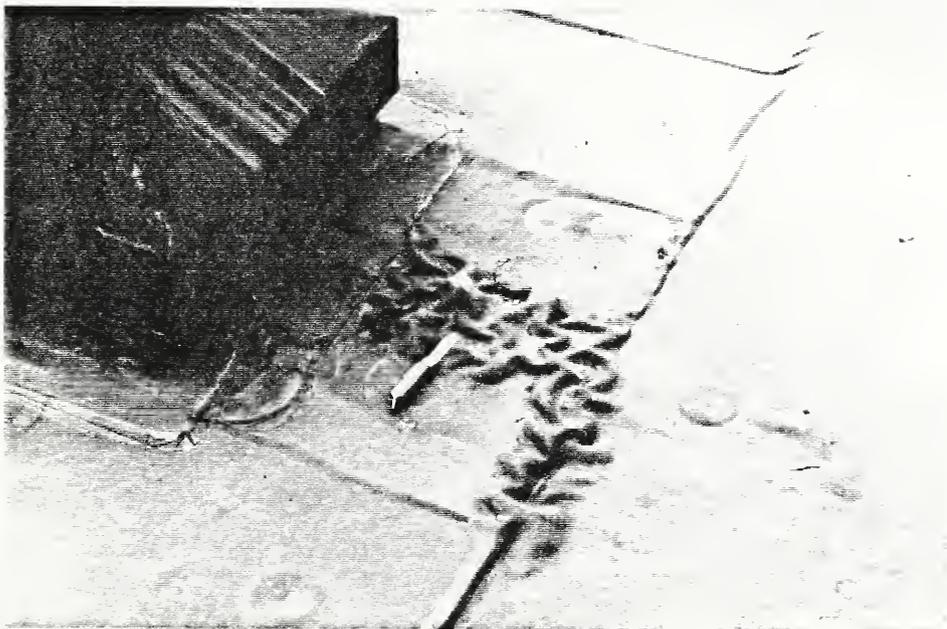
- o oil from mechanical equipment or grease from kitchen appliances were discharged directly on EPDM surfaces (Figure 32); the membranes were seen to be swollen due to the oil or grease. In the cases observed, it was noted that the swelling damage to the membrane was somewhat localized at the spot of the discharge. Apparently, neither flowing of the oil or its washing by rainwater spread the damage over large sections of the EPDM membrane. This suggested that lamination of an oil or grease resistant rubber to the EPDM membrane at the spot of discharge might prevent the local damage.

Figure 32. Oil effluent from a ventilator swelling the EPDM rubber membrane

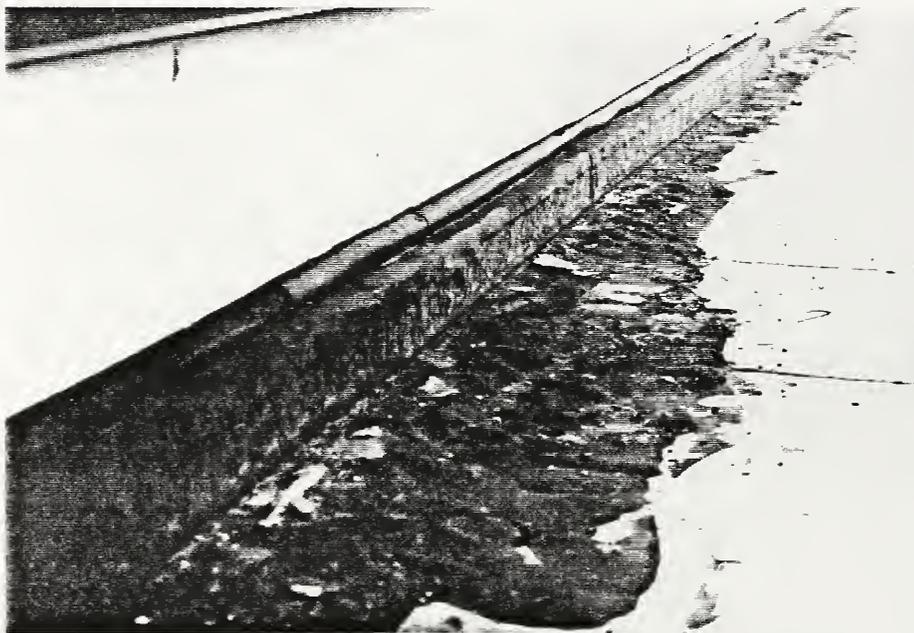
- o the use of asphaltic mastic (plastic cement) as an intended repair material. This was found on isolated spots of four roofs (Figure 33), presumably in attempts to stop leaks. The solvents in these mastics swell EPDM rubber, similarly to the action of some oils discharged from equipment. In cases where mastic was observed, USAF engineering personnel accompanying NIST staff were aware that these solvent-bearing materials should not be used on EPDM. They considered that uninformed shop personnel used the mastics on EPDM in a repair manner that might be routinely done for bituminous roofing. The observations concerning the improper use of mastics illustrate the concerns expressed by field personnel that training and guidelines are needed for the maintenance and repair of EPDM roofing at USAF installations.

Figure 33. Swelling of the membrane due to the application of asphaltic mastic in an attempted repair

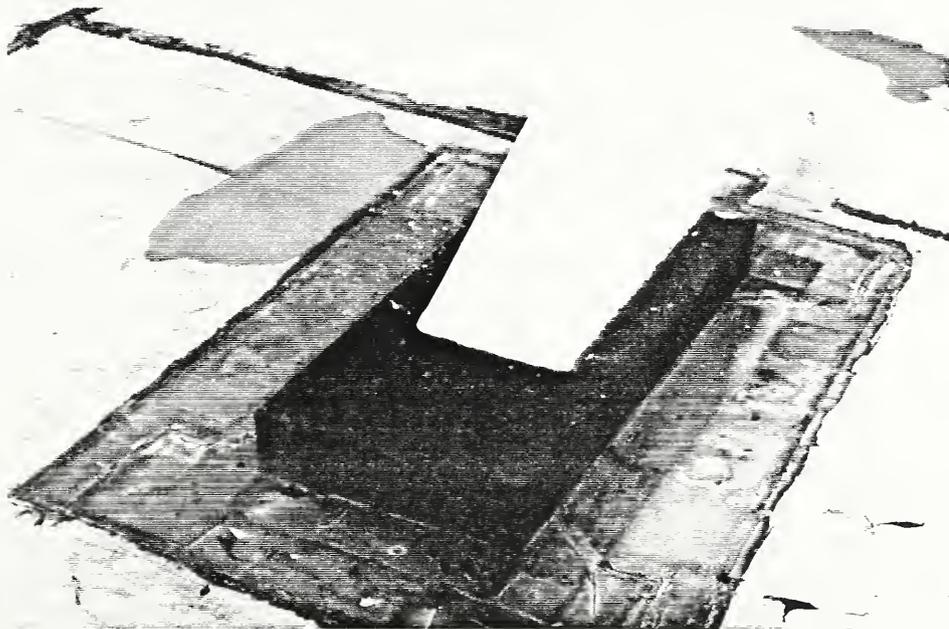
Few pitch pans were observed on the USAF roofs inspected. Where pitch pans were present, they were found to be full of elastomeric sealant which was crack-free and pliable to the touch (Figure 34). The ages of the roofs with the pitch pans ranged from 38 to 68 months. Routine maintenance should include pitch pan inspections to assure that they remain functional.

Figure 34. Pitch pan filled with elastomeric sealant
