NISTIR 4504

# A Field Study of the Performance of EPDM Roofing at Air Force Facilities

Walter J. Rossiter, Jr.  
James F. Seiler, Jr.  
William P. Spencer  
Paul E. Stutzman

January 1991

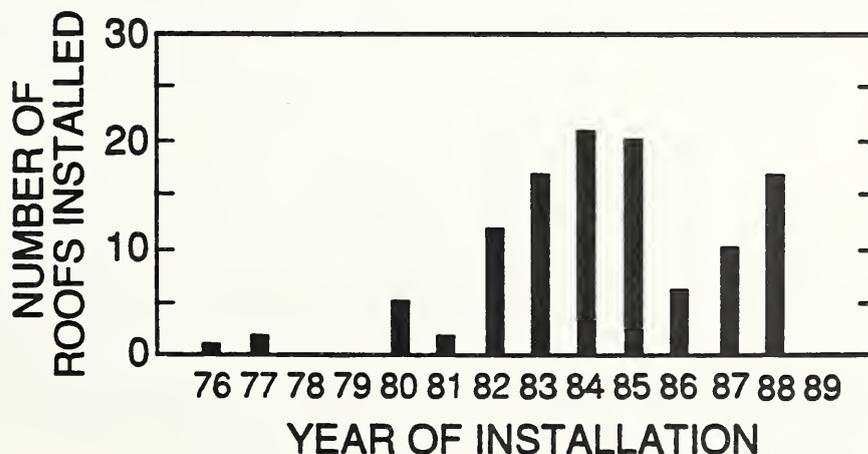
Figure 1. Number of EPDM roofs installed per year, as recorded in the AFESC data file

The roofs were constructed between 1976 and 1988, although the majority were installed in 1982 or later. Figure 1 shows the number of installations per year. Note that the year of construction was not always given in the data file as Figure 1 only makes reference to 113 roofs. No roofs were recorded for 1989 because the data file had not been updated at the time of the review.

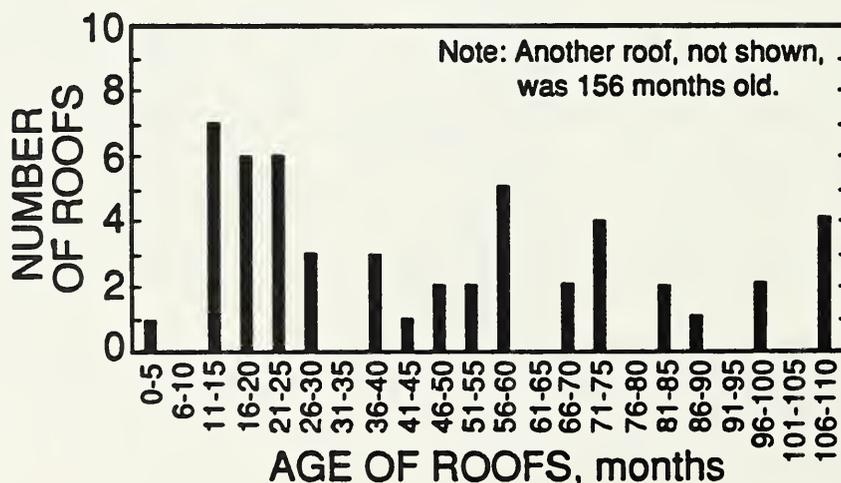
Figure 2. Number and age of the USAF EPDM roofs inspected

EPDM systems from eight manufacturers were represented in the roof sampling. However, consistent with the AFESC database of USAF EPDM roofs (Table 1), two manufacturers accounted for about 50 percent of the roofs inspected. The age of the roof systems ranged from 3 to 156 months. Figure 2 presents a frequency plot (in 5-month increments) of the ages of the roofs inspected. As evident in Figure 2, the ages of the inspected roofs were well spread over the range up to 110 months, although about 40 percent were 30 months old or less. For the vast majority of the roof systems, the membrane was either adhered (about 50 %) or ballasted (about 40 %), with only three roofs having the membranes mechanically fastened. Half of the ballasted membranes were incorporated in protected membrane roof (PMR) systems with the insulation above the membrane and under the ballast.

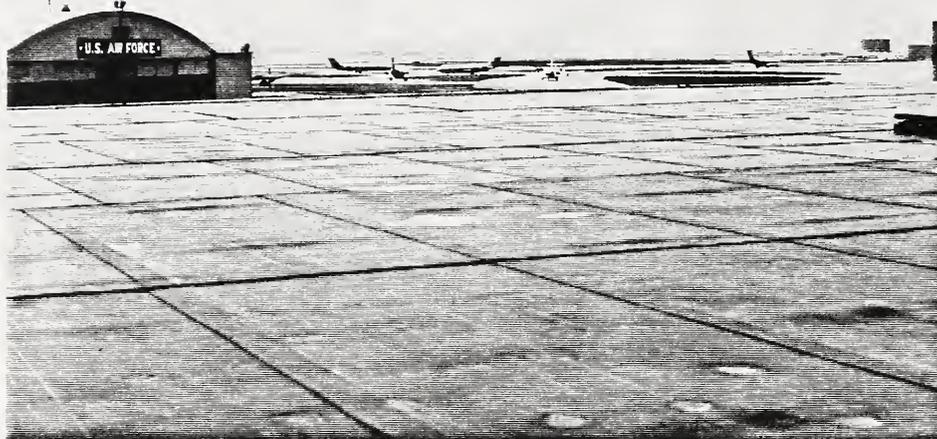
Figure 12. A typical adhered-membrane system

The results of the inspections of the adhered systems were positive, with no visual indications that membrane securement was inadequate. Figure 12 shows an adhered membrane system, typical of those inspected during the survey. The membranes generally appeared tight on the substrates with no evidence of loose areas. In the few cases where seam samples of adhered membranes were taken, the rubber sheets were seen to be well bonded to the substrates. Discussions of the performance of adhered systems with field personnel indicated that securement of the membrane had been satisfactory for most of the roofs. However, two significant anecdotes of wind damage to adhered membranes were reported.

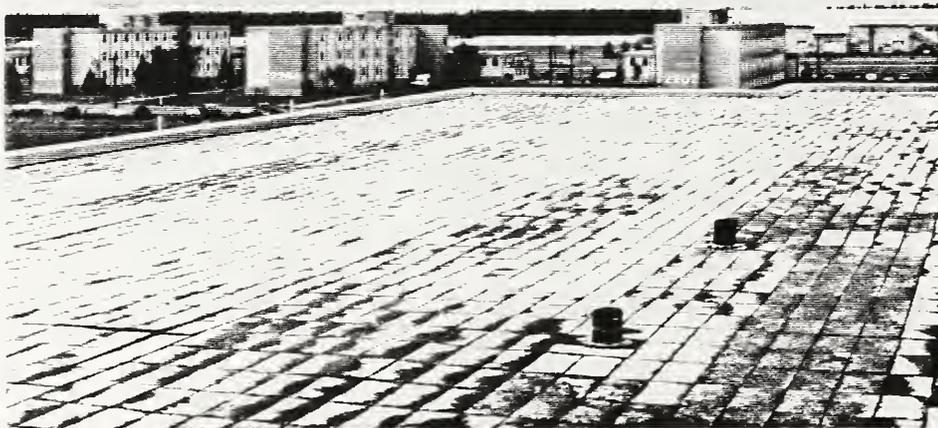
Figure 19. A typical protected membrane roof with concrete pavers

For most of the PMR systems, the base flashings at the perimeters of the buildings were not visible. Figure 19 shows a section of a typical protected membrane roof with concrete pavers used as ballast in Alaska. Note the sheet metal covering obscuring the base flashing at the perimeter of the building.

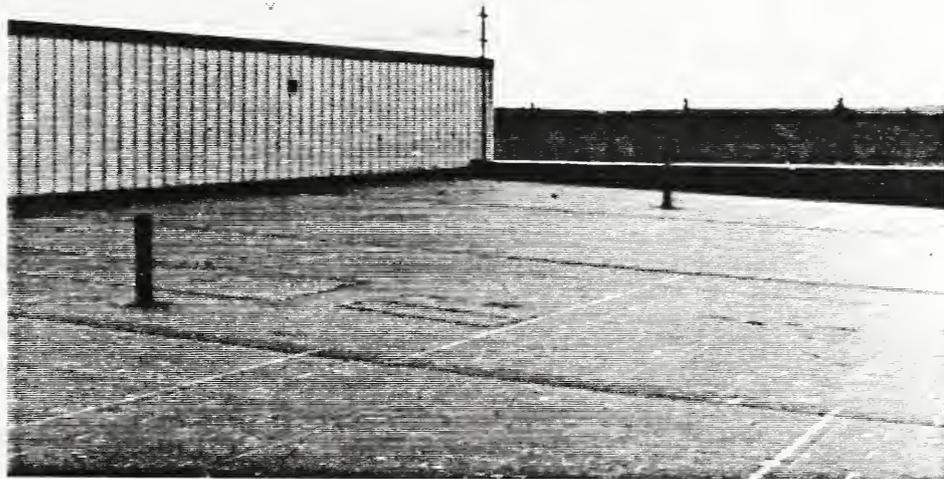
Figure 28. Illustration of the slope incorporated in many of the roofs inspected

3.4.10 Slope and Drainage. For the majority of the roofs inspected, sufficient slope was observed on the roofs (Figure 28), and the roofs generally drained well. Note in Figure 28 the extent of slope as indicated by the changing height of the parapet wall at the edge of the roof. In addition, where interior drains were observed, they were generally free of debris to provide unrestricted drainage. At one installation, the drain of an exterior gutter was blocked with leaves from an overhead tree. At another facility, an exterior gutter was clogged, but the source of the debris was unknown.

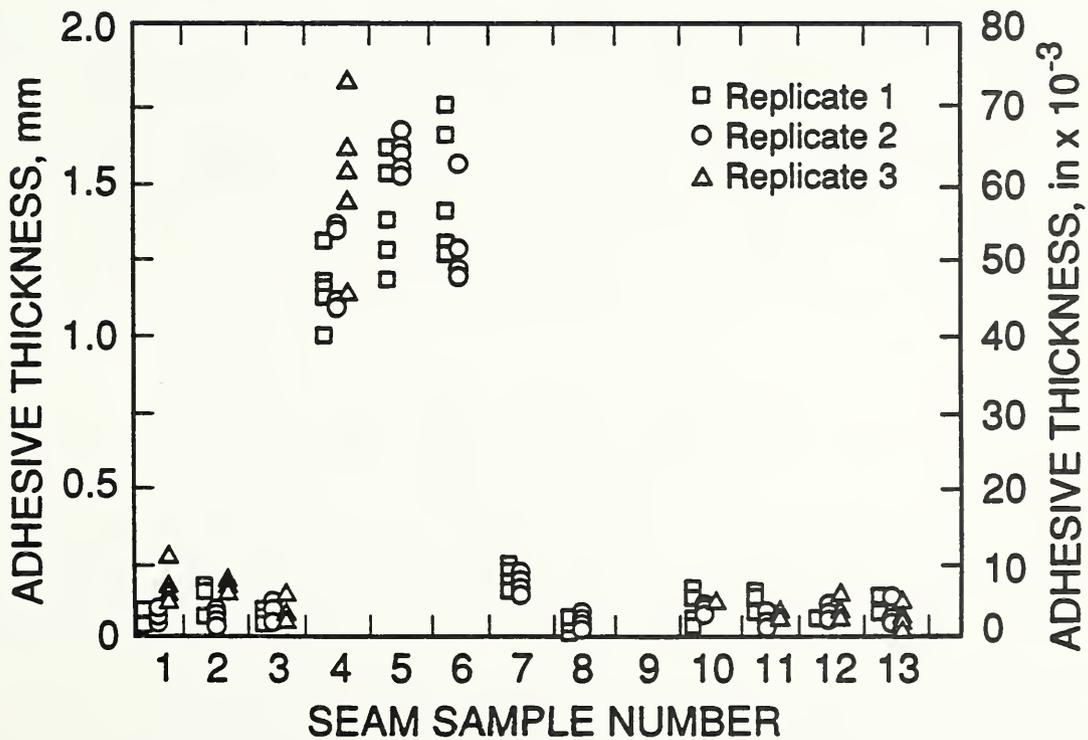
Figure 36. Adhesive thicknesses of seam samples

With the exception of the seam samples from New Boston (nos. 4 - 6), the thicknesses of the adhesive layers were 0.008 in. (0.20 mm) or less (Table 6). These values were comparable to adhesive thicknesses found for other field-prepared seams, and have been considered to be relatively thin [27]. Seams having relatively thin adhesive layers may not be as resistant to peel failure under creep conditions, as they could be if they had thicker adhesive layers [16].
