**EVALUATION OF METAL FASTENERS  
CORRODED FROM CONTACT WITH  
PRESERVATIVE TREATED WOOD**

Cary Black, Stan Choiniere, André Desjarlais, Mike Ennis

RCI 25<sup>th</sup> International Convention and Trade Show  
Rosen Shingle Creek Resort, Orlando Florida  
March 2010

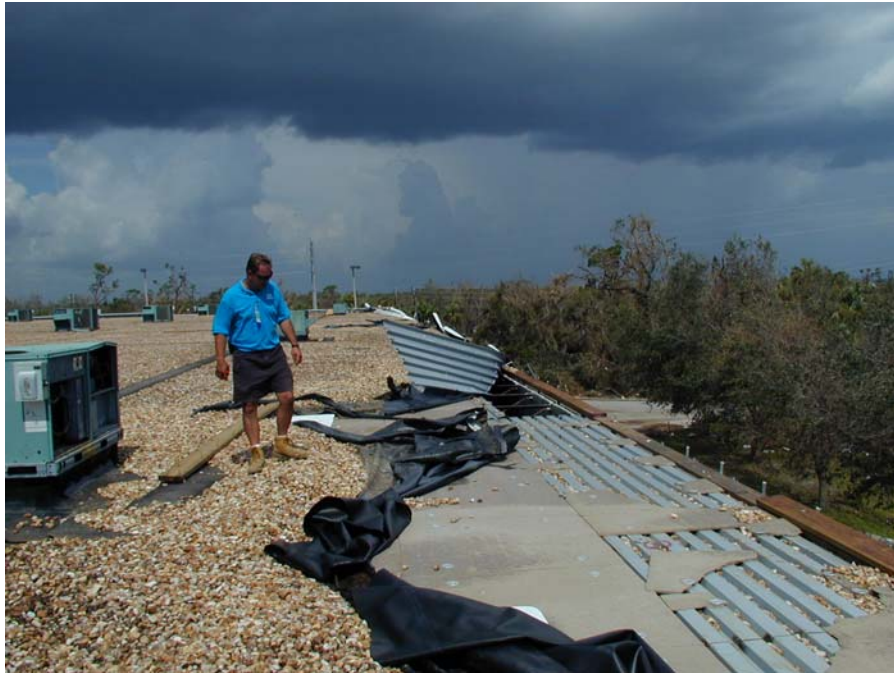
Figure 1 – Large retail building, Punta Gorda, FL, Hurricane Charley  
Photo courtesy of RICOWI

Post hurricane investigations conducted by the Roofing Industry Committee on Weather Issues (RICOWI) has consistently shown that in many cases damage to a low slope roof system during high wind events begins when the edge of the assembly becomes disengaged from the building structure. Once this occurs, the components of the roof system (membrane, insulation, etc.) are exposed. Damage then propagates across the entire roof system by peeling of the roof membrane, insulation, or a combination of the two. (see Figure 1)

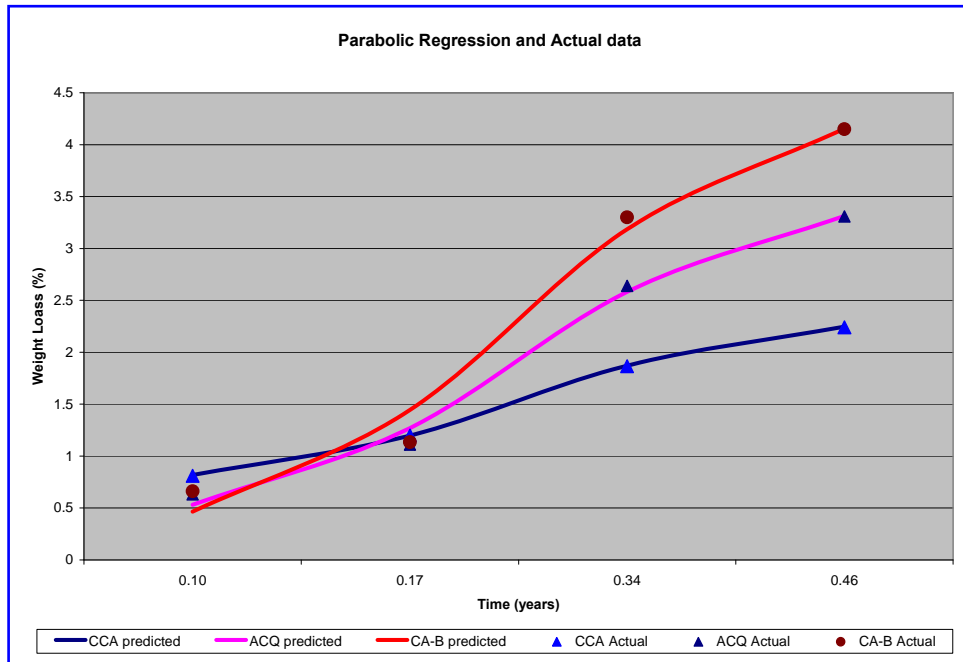
Figure 2- Parabolic Rate Corrosion Growth vs Actual Measurements

Figure 2 illustrates the gravimetric profiles of the treatments tested over time, reflecting a parabolic rate mechanism for the corrosion observed in all treatments studied (ACQ, CA-B, and CCA).

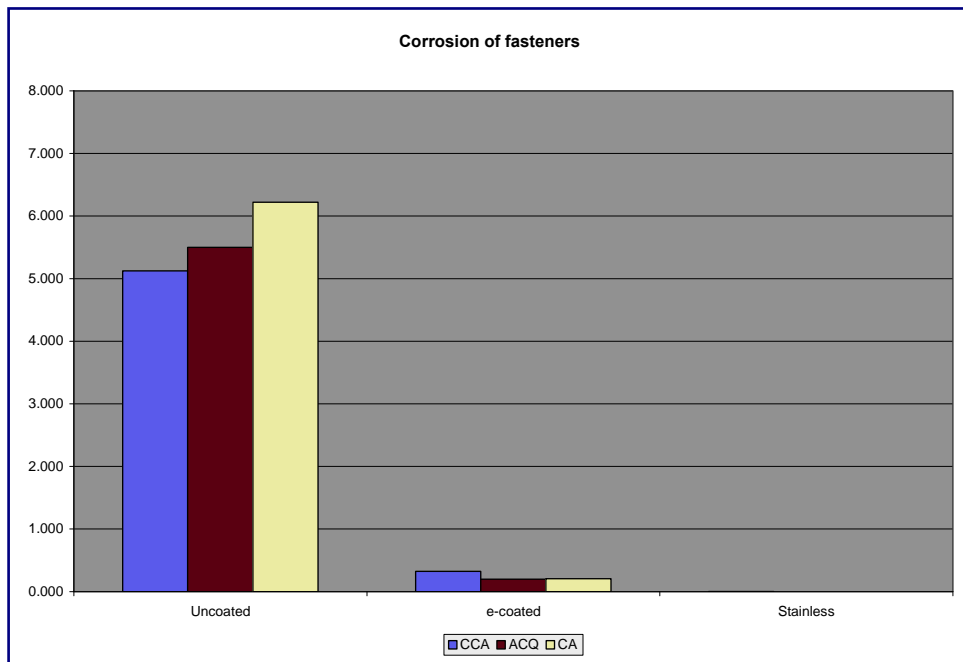
Figure 3- Extent of corrosion up to 2528 hours at 140 °F and 90% RH for uncoated 1022 steel, e-coated 1022 steel, and stainless steel fasteners

- 1) Figure 3 illustrates the differences observed in the various treatments used in Phase 1 for extent of corrosion with stainless steel, e-coated carbon steel and uncoated carbon steel. The stainless steel fasteners exhibited no corrosion in any of the lumber treatments tested, and thus were eliminated from further studies. Further, little or no corrosion was observed in the untreated or SBX treated lumber.
- 2) Corrosion was observed in the fasteners emplaced in CCA, ACQ, and CA-B treated lumber.
- 3) Where corrosion was observed (only on samples exposed to 90% RF), the weight loss data from the e-coated carbon steel fasteners fit parabolic rate models with correlation coefficients (R-squared values) ranging from 0.87 to 0.99 (indicating good fits). The Arrhenius-like relationship was found to be:

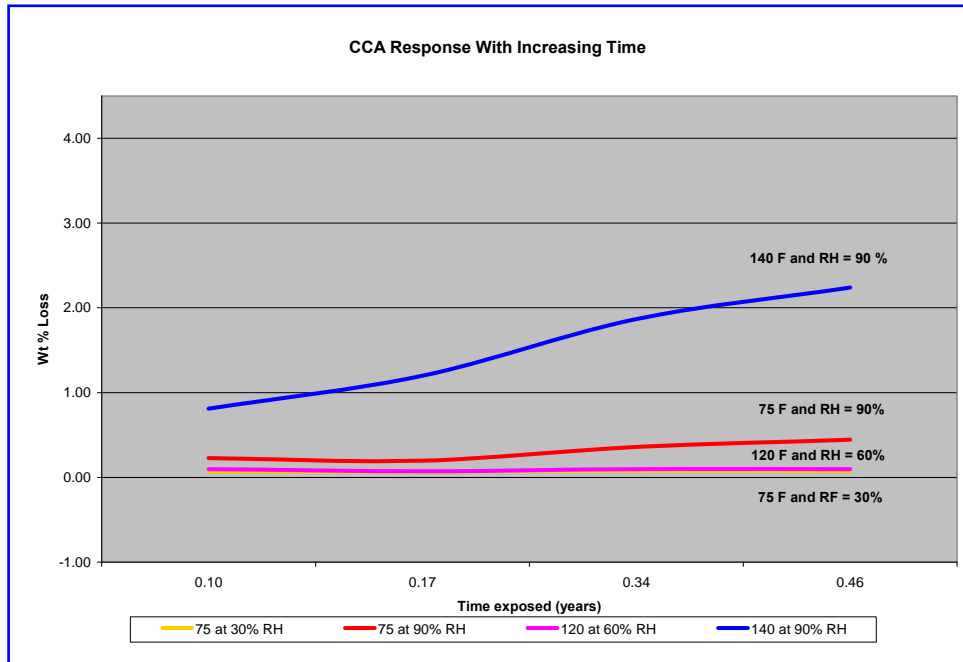
Figure 4- Response curves for e-coated fasteners in CCA treated lumber in the various environments tested.

- 7) Figures 4 through 6 illustrate the various responses with increasing exposure time for the different treatments tested. Only those environments held at 90% relative humidity indicated corrosion.

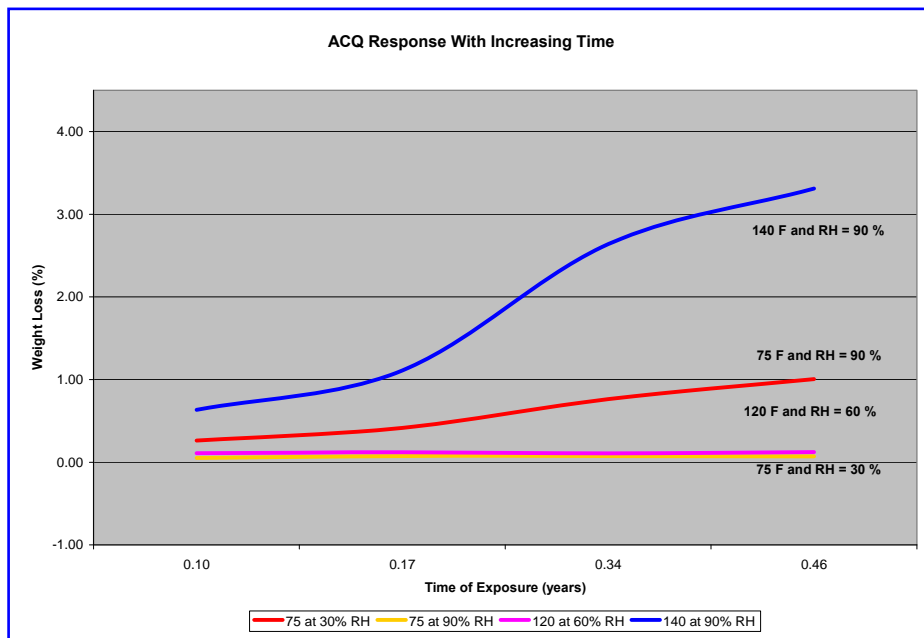
Figure 5- Response curves for e-coated fasteners in ACQ treated lumber in the various environments tested.

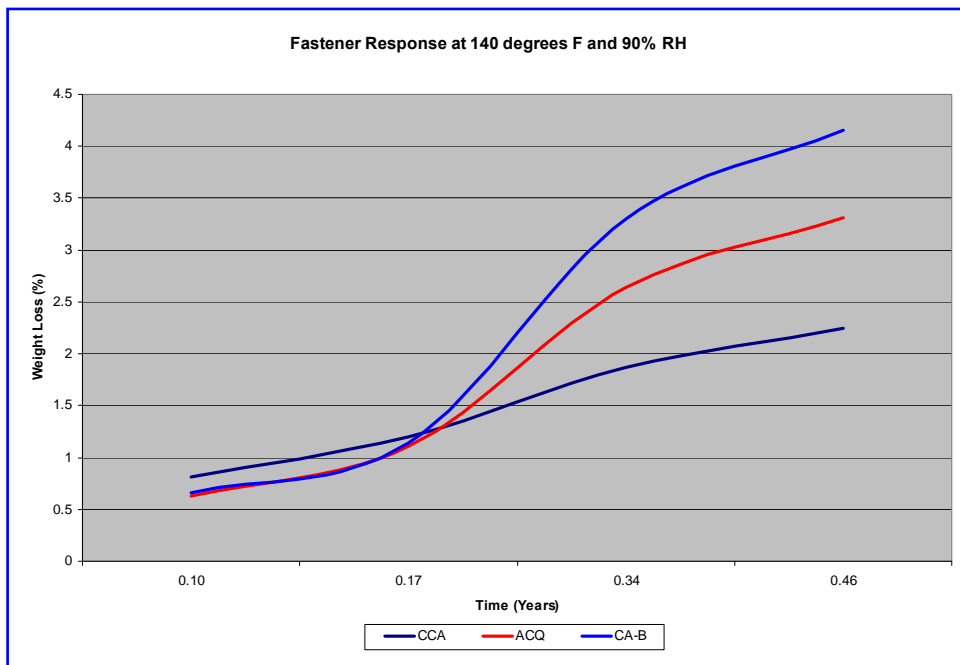
Figure 7- Fastener Responses for Different treatments at 140 °F and 90 % RH

- 8) Figures 7 and 8, respectively illustrate the response for those treatments held at 90% RH.
- 9) Corrosion was only observed for those conditions where the relative humidity was held at 90 % RH and at 140 and 75 degrees respectively. No corrosion was observed for samples held at 120 °F and 60 % RH, or for those held at 75 °F and 30% RH (Figures 9 and 10). The relative humidity has to be sustained at high levels approaching 90 % in order for the wood to retain sufficient moisture for a galvanic cell to be functional, thus, is a requirement for corrosion to occur.

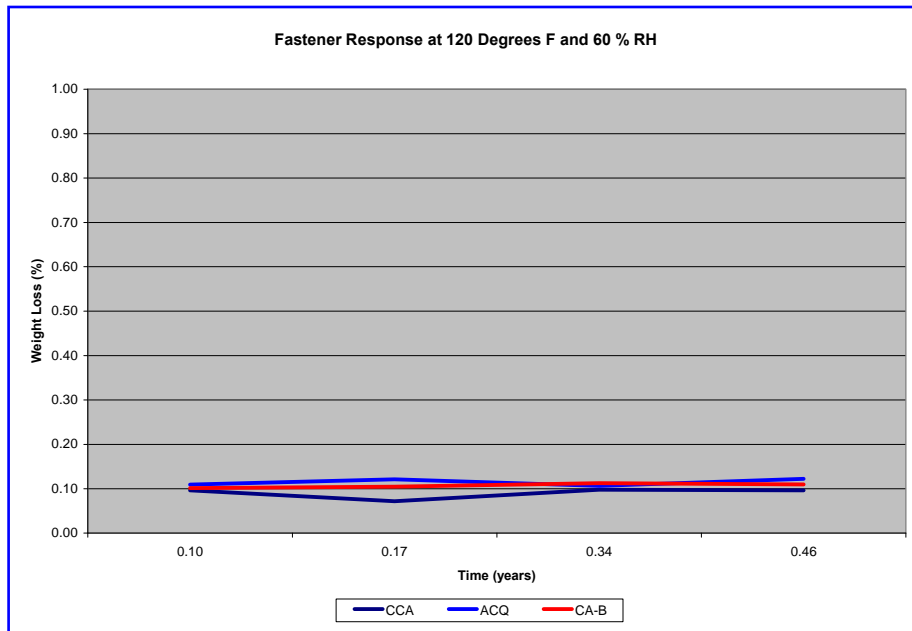
Figure 9- Fastener Responses for Different treatments at 120 °F and 60 % RH.

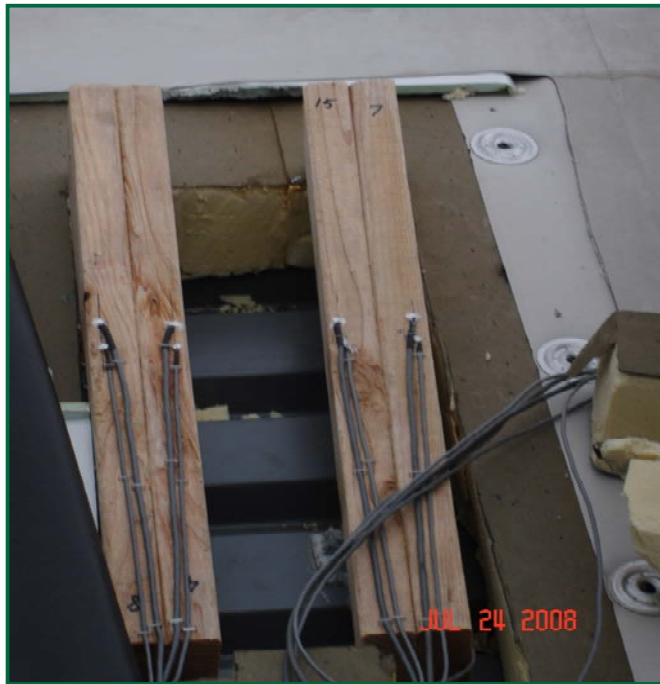
Figure 12 – Installed instrumentation

Once at the test location the test samples were unwrapped and instrumented with temperature and moisture content sensors. Figure 11 is a schematic representation of the instrumentation used in this study. Figure 12 shows the actual test samples used in the experiment. Insulation was cut and removed so that the test samples could be installed directly on the roof deck. (See Figure 13 )

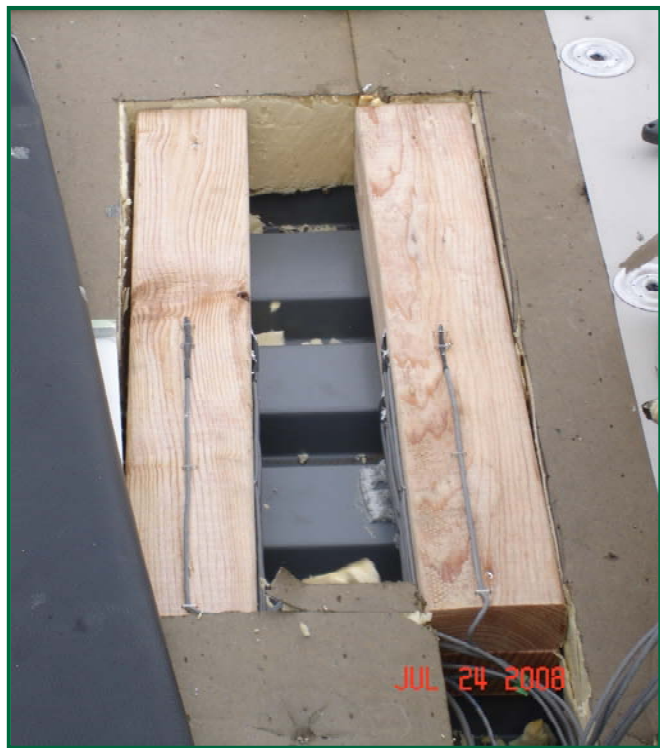
Figure 13 – Simulated wood nailers installed on roof deck

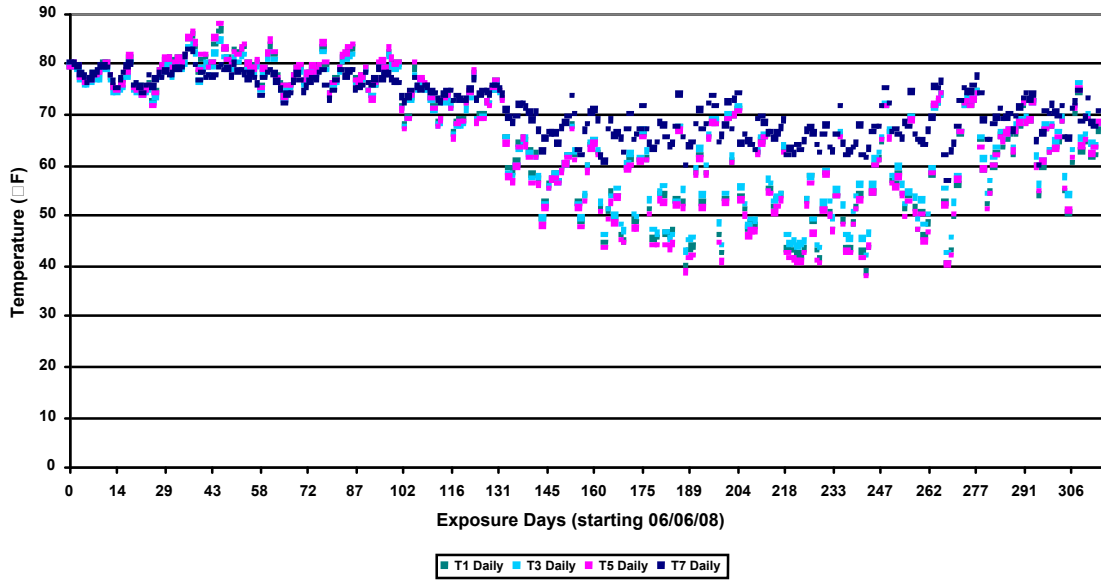
Figure 14  
Jackson, MS Average Daily Temperatures

The average daily temperatures within the wood nailers were highest at the Jackson, MS test location. At this location temperatures remained above 70F for the first 100 days of exposure (test was initiated June 5, 2008). Temperatures ranged from 40F to 70F for the next 205 days of exposure. The relative humidity within the wood nailer at this location ranged from 85% to 100% at the start of the test and dropped to a range of 60% to 70% after 120 days (except for the 200 to 22 days time period). See Figures 14 and 15 for a summary of this data.

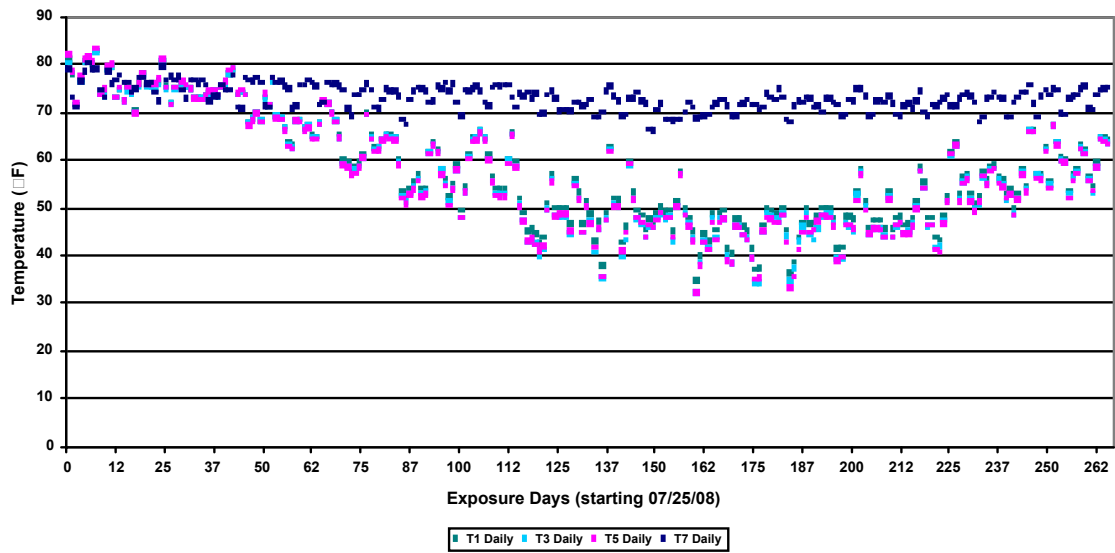
Figure 16  
Agawam, MA Average Daily Temperature

At the Agawam, MA location the temperature within the wood nailer ranged from 70F to 80F for the first 50 days of the test (test started on July 24, 2008), dropped to a range of 50F to 70F for the next 60 days, and then dropped to a range of 35F to 50F for the next 90 days before beginning to increase again. The relative humidity within the simulated wood nailers for this location started at 90% to 100% and dropped to a maximum of 60% after 80 days for the remainder of the test period (310 days). See Figures 16 and 17 for a summary of this test data.

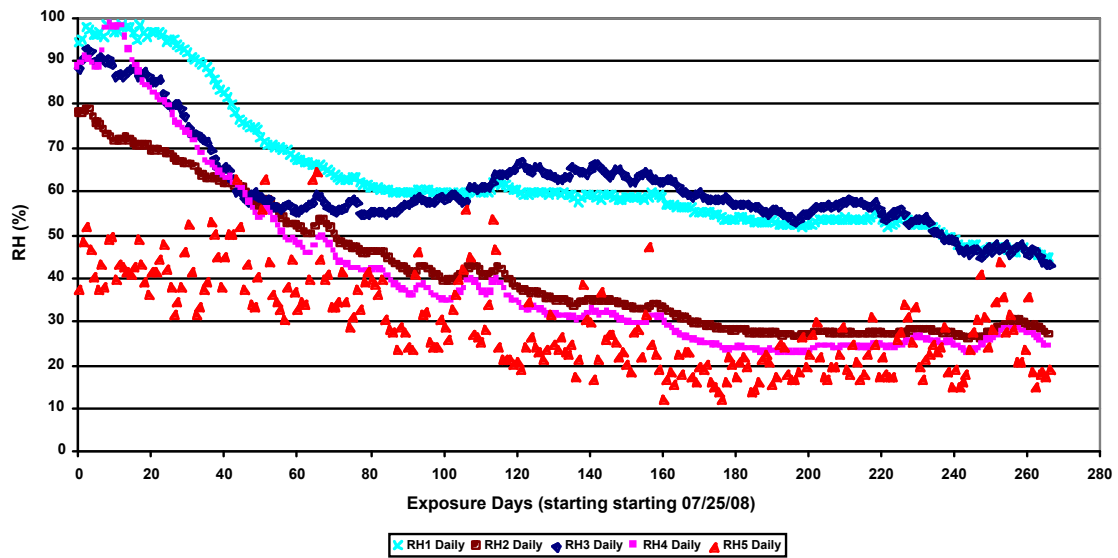
Figure 17  
Agawam, MA Average Daily RH

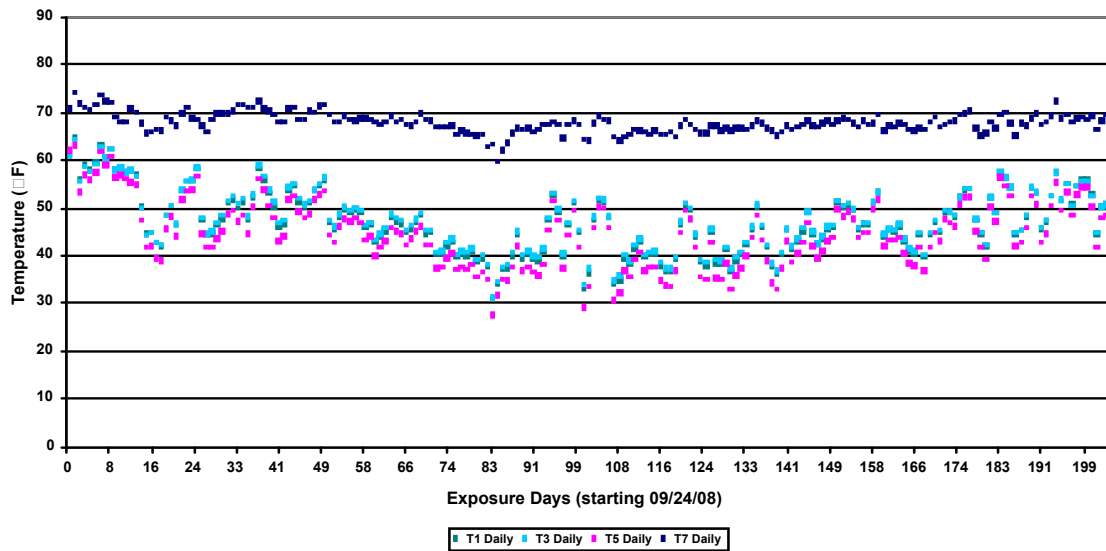
Figure 18  
Grants Pass, OR Average Daily Temperatures

At the Grants Pass, OR test site the test temperatures within the simulated wood nailers ranged from 30F to 60F for the duration of the test. At this location the moisture content sensors in one of the test samples malfunctioned, however the moisture content sensors in the duplicate sample performed well. The relative humidity at this location started at approximately 90% and dropped to a range of 45% to 55% after 70 days where it remained for the duration of the test. See Figures 18 and 19 for a summary of this test data.

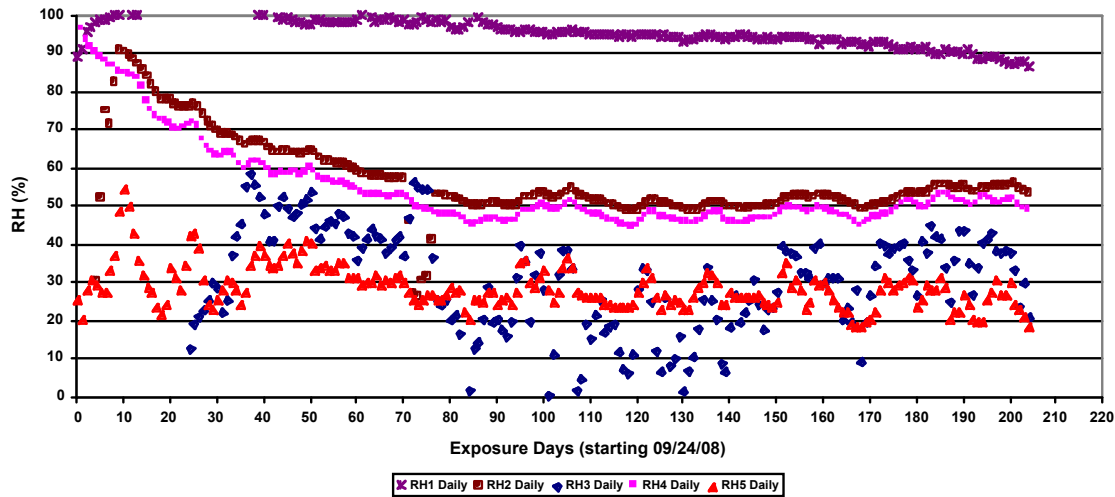
Figure 19  
Grants Pass, OR Average Daily RH

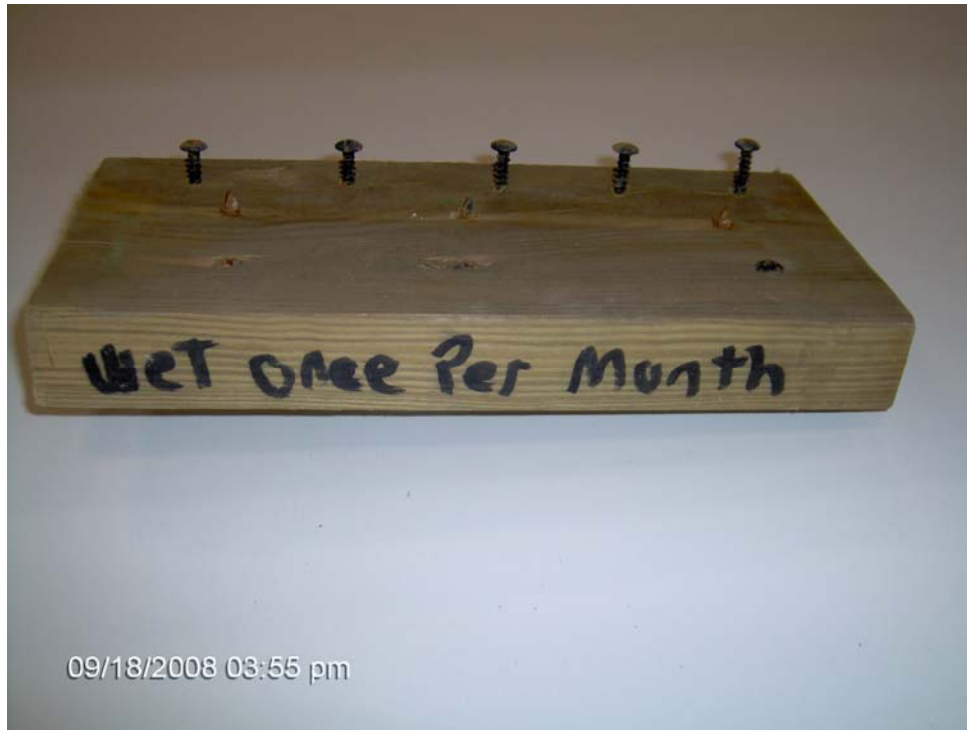
Figure 20 – Visual test set-up

- Epoxy coated screws were installed into three 1 foot long pieces of ACQ treated 2" x 4"s
- One sample was left as received, a second sample was soaked for 24 hours in a bucket of water simulating rain on the nailer during construction, and the 3<sup>rd</sup> sample has been soaked in a bucket of water for 24 hours the 1<sup>st</sup> business day of every month (64 months) which represents a very extreme condition.
- An aluminum term bar was also installed on each piece since aluminum is reported to be very susceptible to corrosion in contact with ACQ. (see Figure 1)
